The Ultimate Guide to PV Connector Safety

BAD CONNECTORS CAUSE PV FIRES

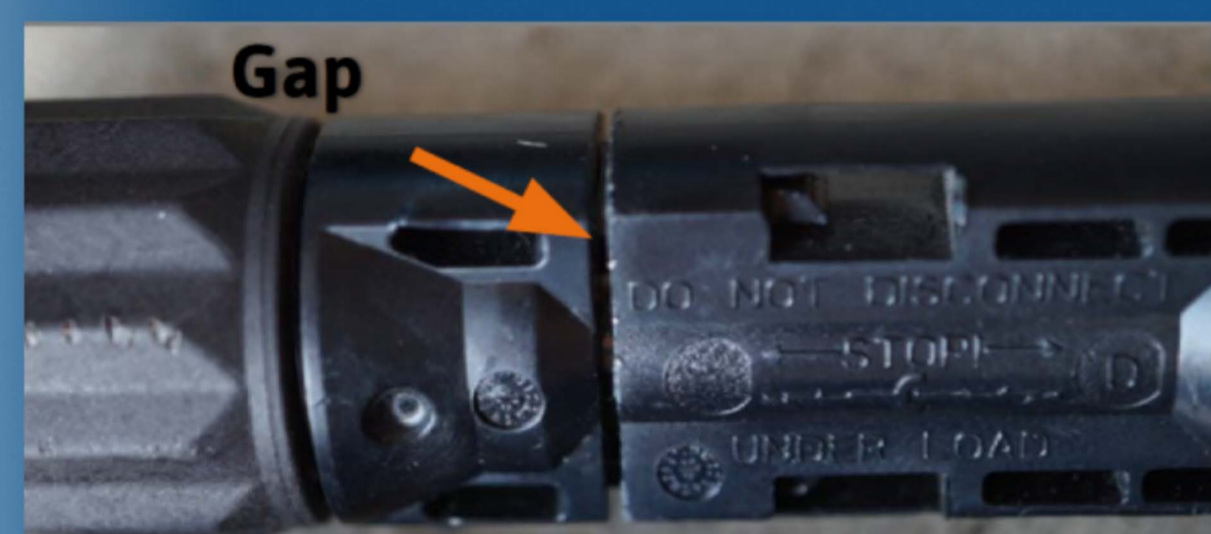
Poor or Loose Connections lead to increased resistance over time.

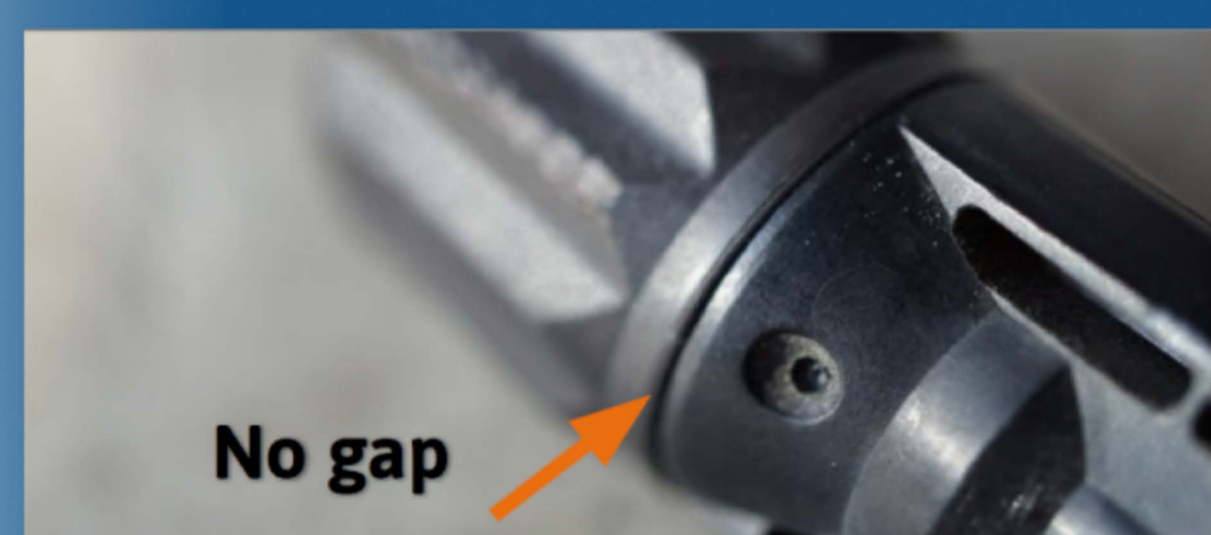
Over-torqued Backnuts compromise the seal and integrity of the connector body.

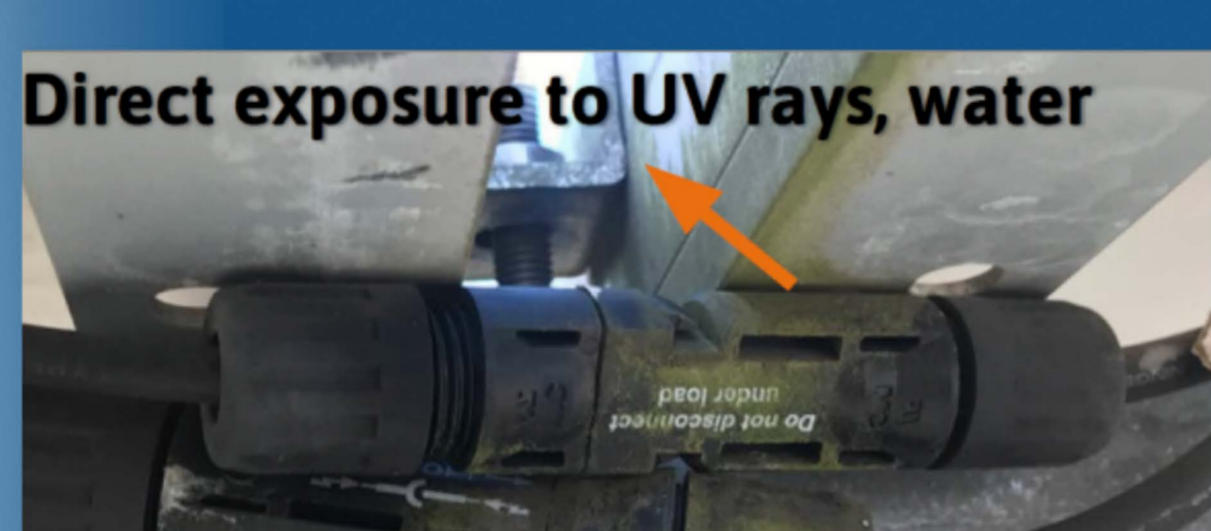
Water and Sunlight Exposure will degrade the connector material over time.

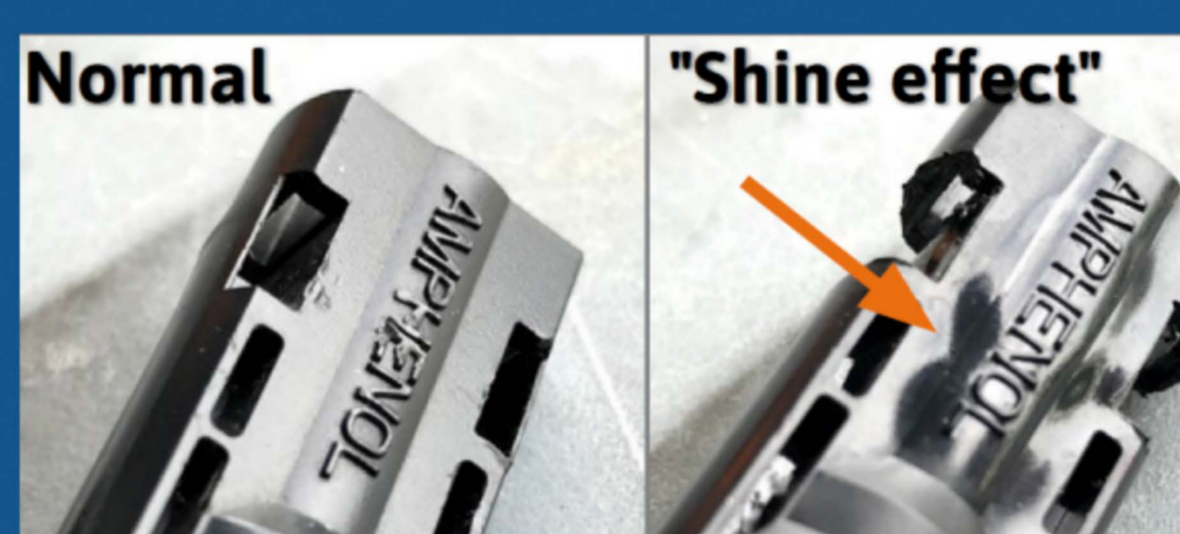
Signs of overheating due to operating outside material temperature range.

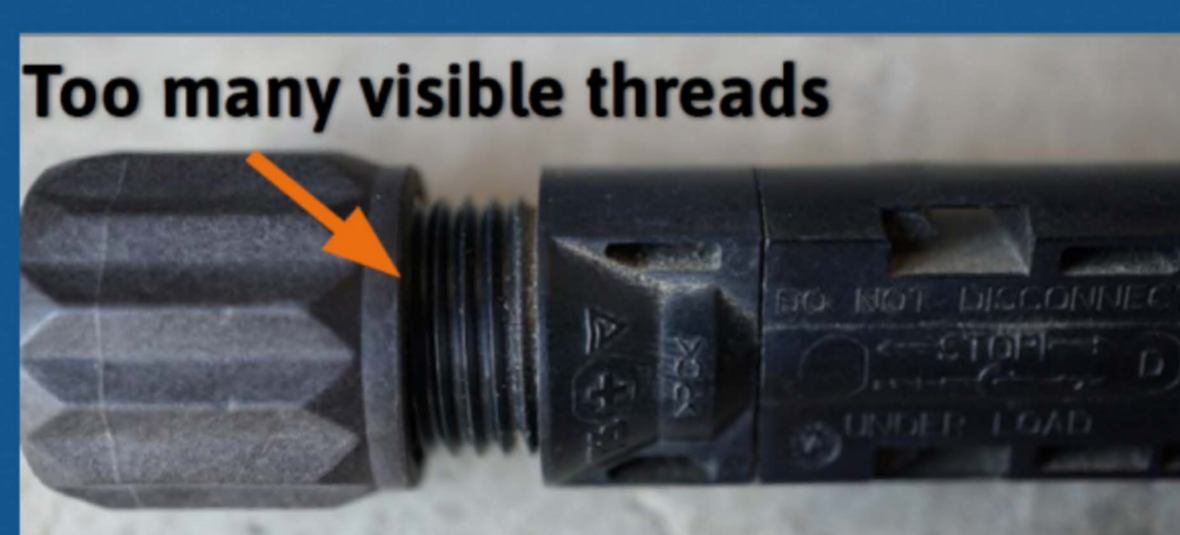
Under-torqued Backnuts do not properly seal the gasket around the conductor jacket.

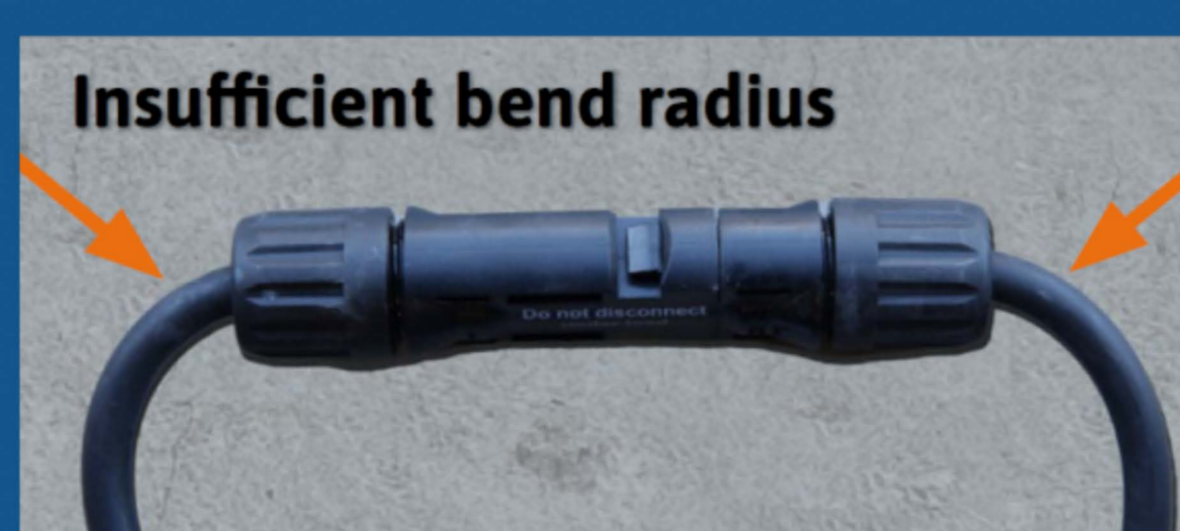
Insufficient Bend Radius compromises the integrity of the backnut seal and internal crimp.

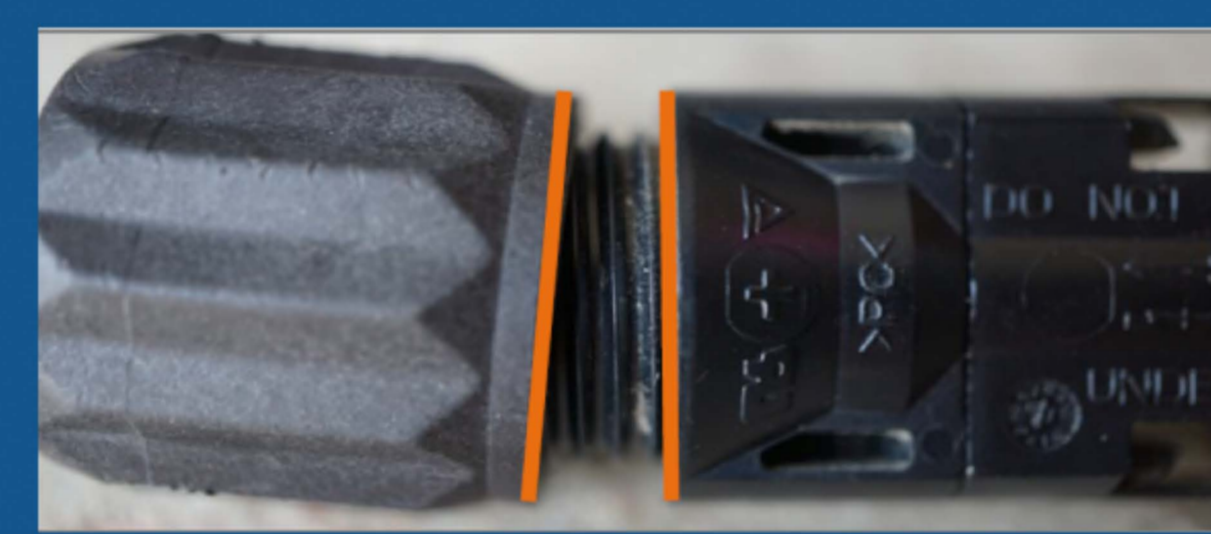
Cross-threaded Backnuts can compromise the watertight seal.

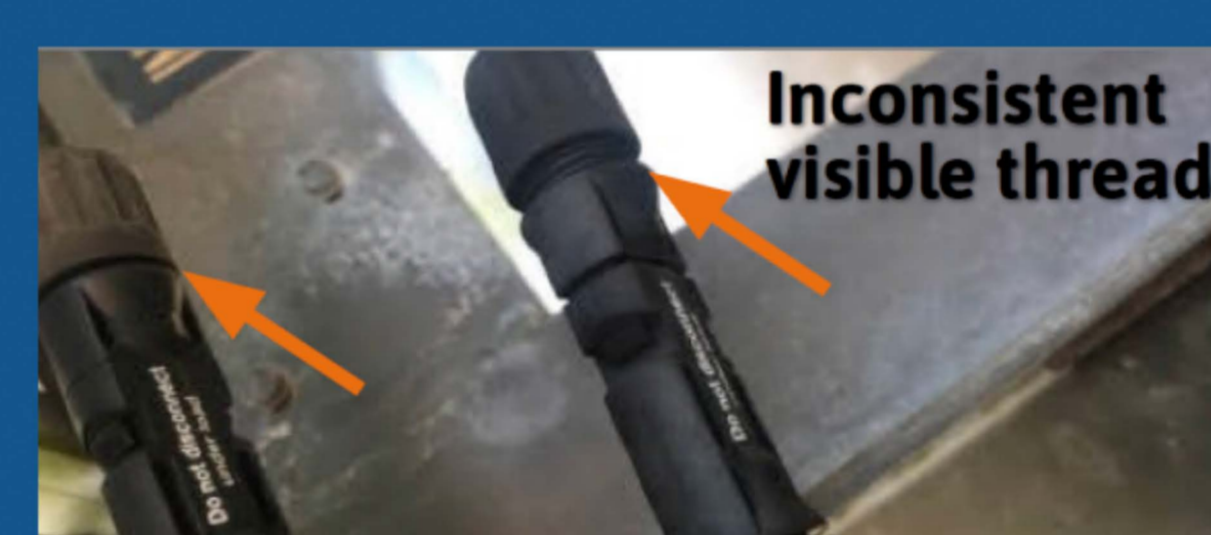
Inconsistent Install Methods are indicated by inconsistent threads at the backnut.

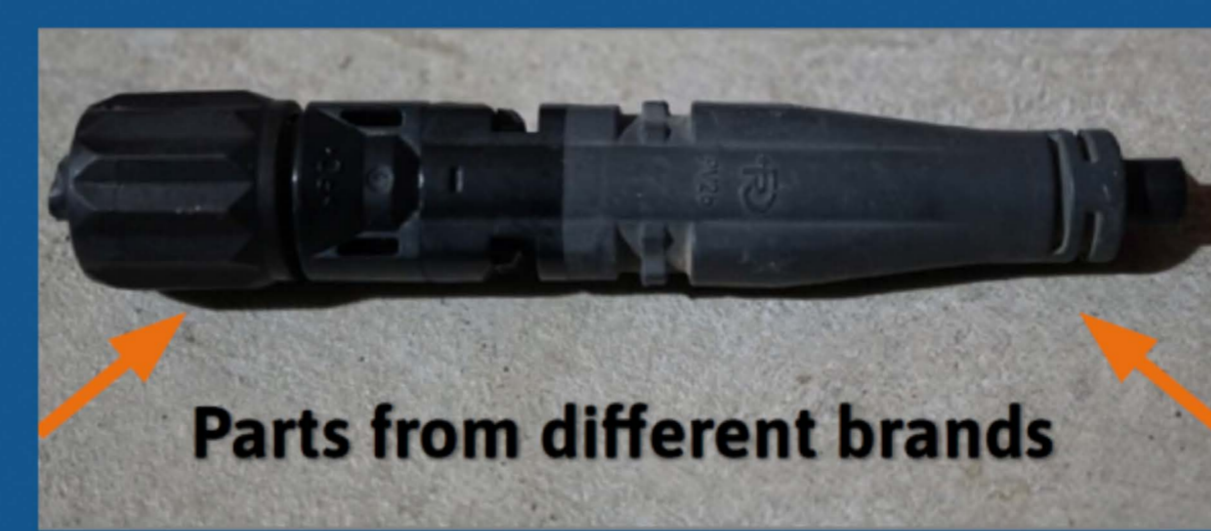
Crossmated Connectors are not tested together and the internal fit is usually out of manufacturer specifications.

- DO NOT CROSSMATE** connectors
- SPECIFY & VALIDATE** manufacturer, type, & authenticity
- INSTALL CORRECTLY** with manufacturer-approved tools
- QA/QC INSTALLATION** requirements in EPC contracts
- INSPECT REGULARLY** during preventative maintenance

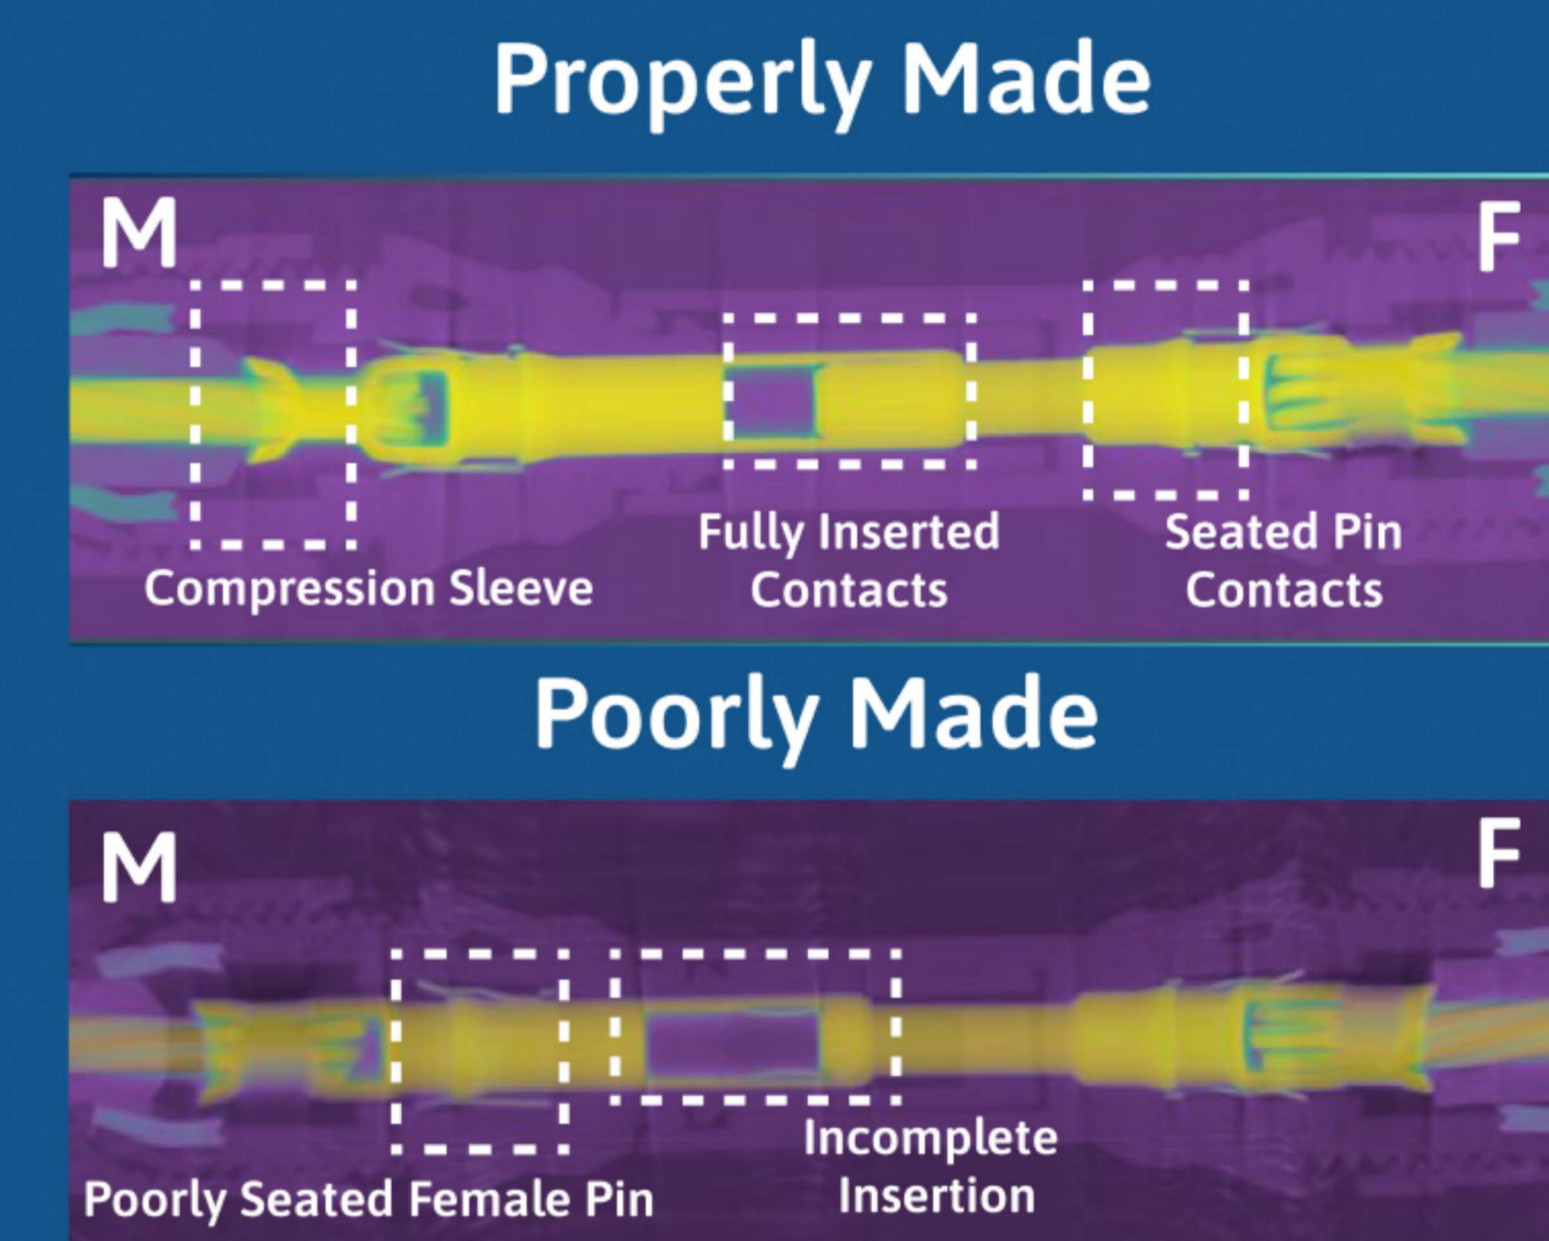
Inside a PV Connector

X-ray Computed Tomography (XCT) provides 3D images of the pin contacts within a connector. The lack of surface area contact in poorly made connectors is clearly evident.

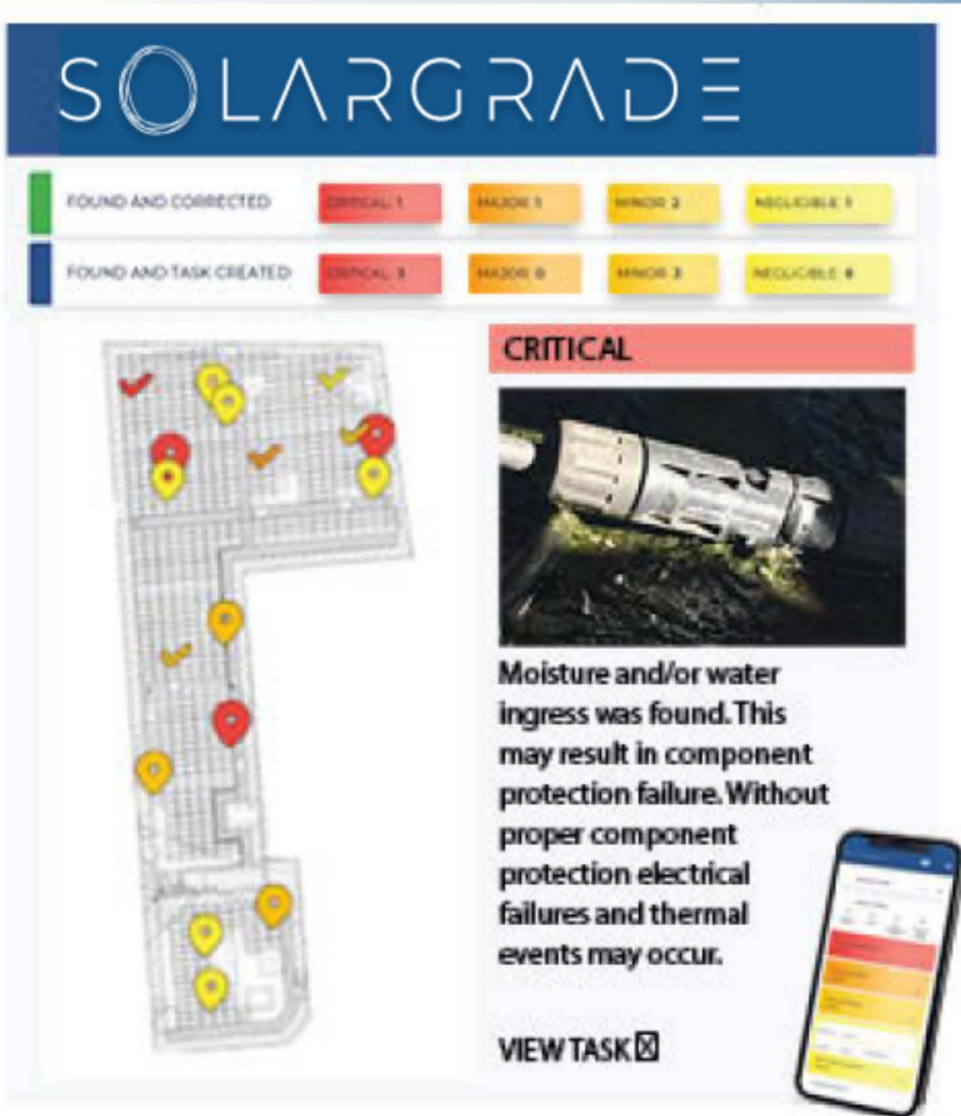
- **Connectors can be difficult to locate and poor wire management is common.** Inspectors often crawl on their knees with hand-held thermal cameras.
- **Cross-mated connectors are frequently found on homerun cables.** This classic problem usually occurs because modules come with a connector type that the EPC does not have readily on-hand.
- **Poor installation practices are often to blame for failures.** Connectors may be exposed to the elements, resting on roof membranes, have a tight bend radius, or poorly torqued backnuts, among other issues.
- **Hot connectors are the most obvious indicator of underlying issues.** These connectors have higher operating temperatures than other connectors installed on-site, which indicates a higher electrical resistance.
