A Rare Case of Upper Gastrointestinal Bleed Caused by Cervical Hardware Migration With Esophageal Perforation

Omar Saab, MD¹, Marwah Algodí, MD²; Zhi Alan Cheng, MD³, Constantine Fisher, MD³

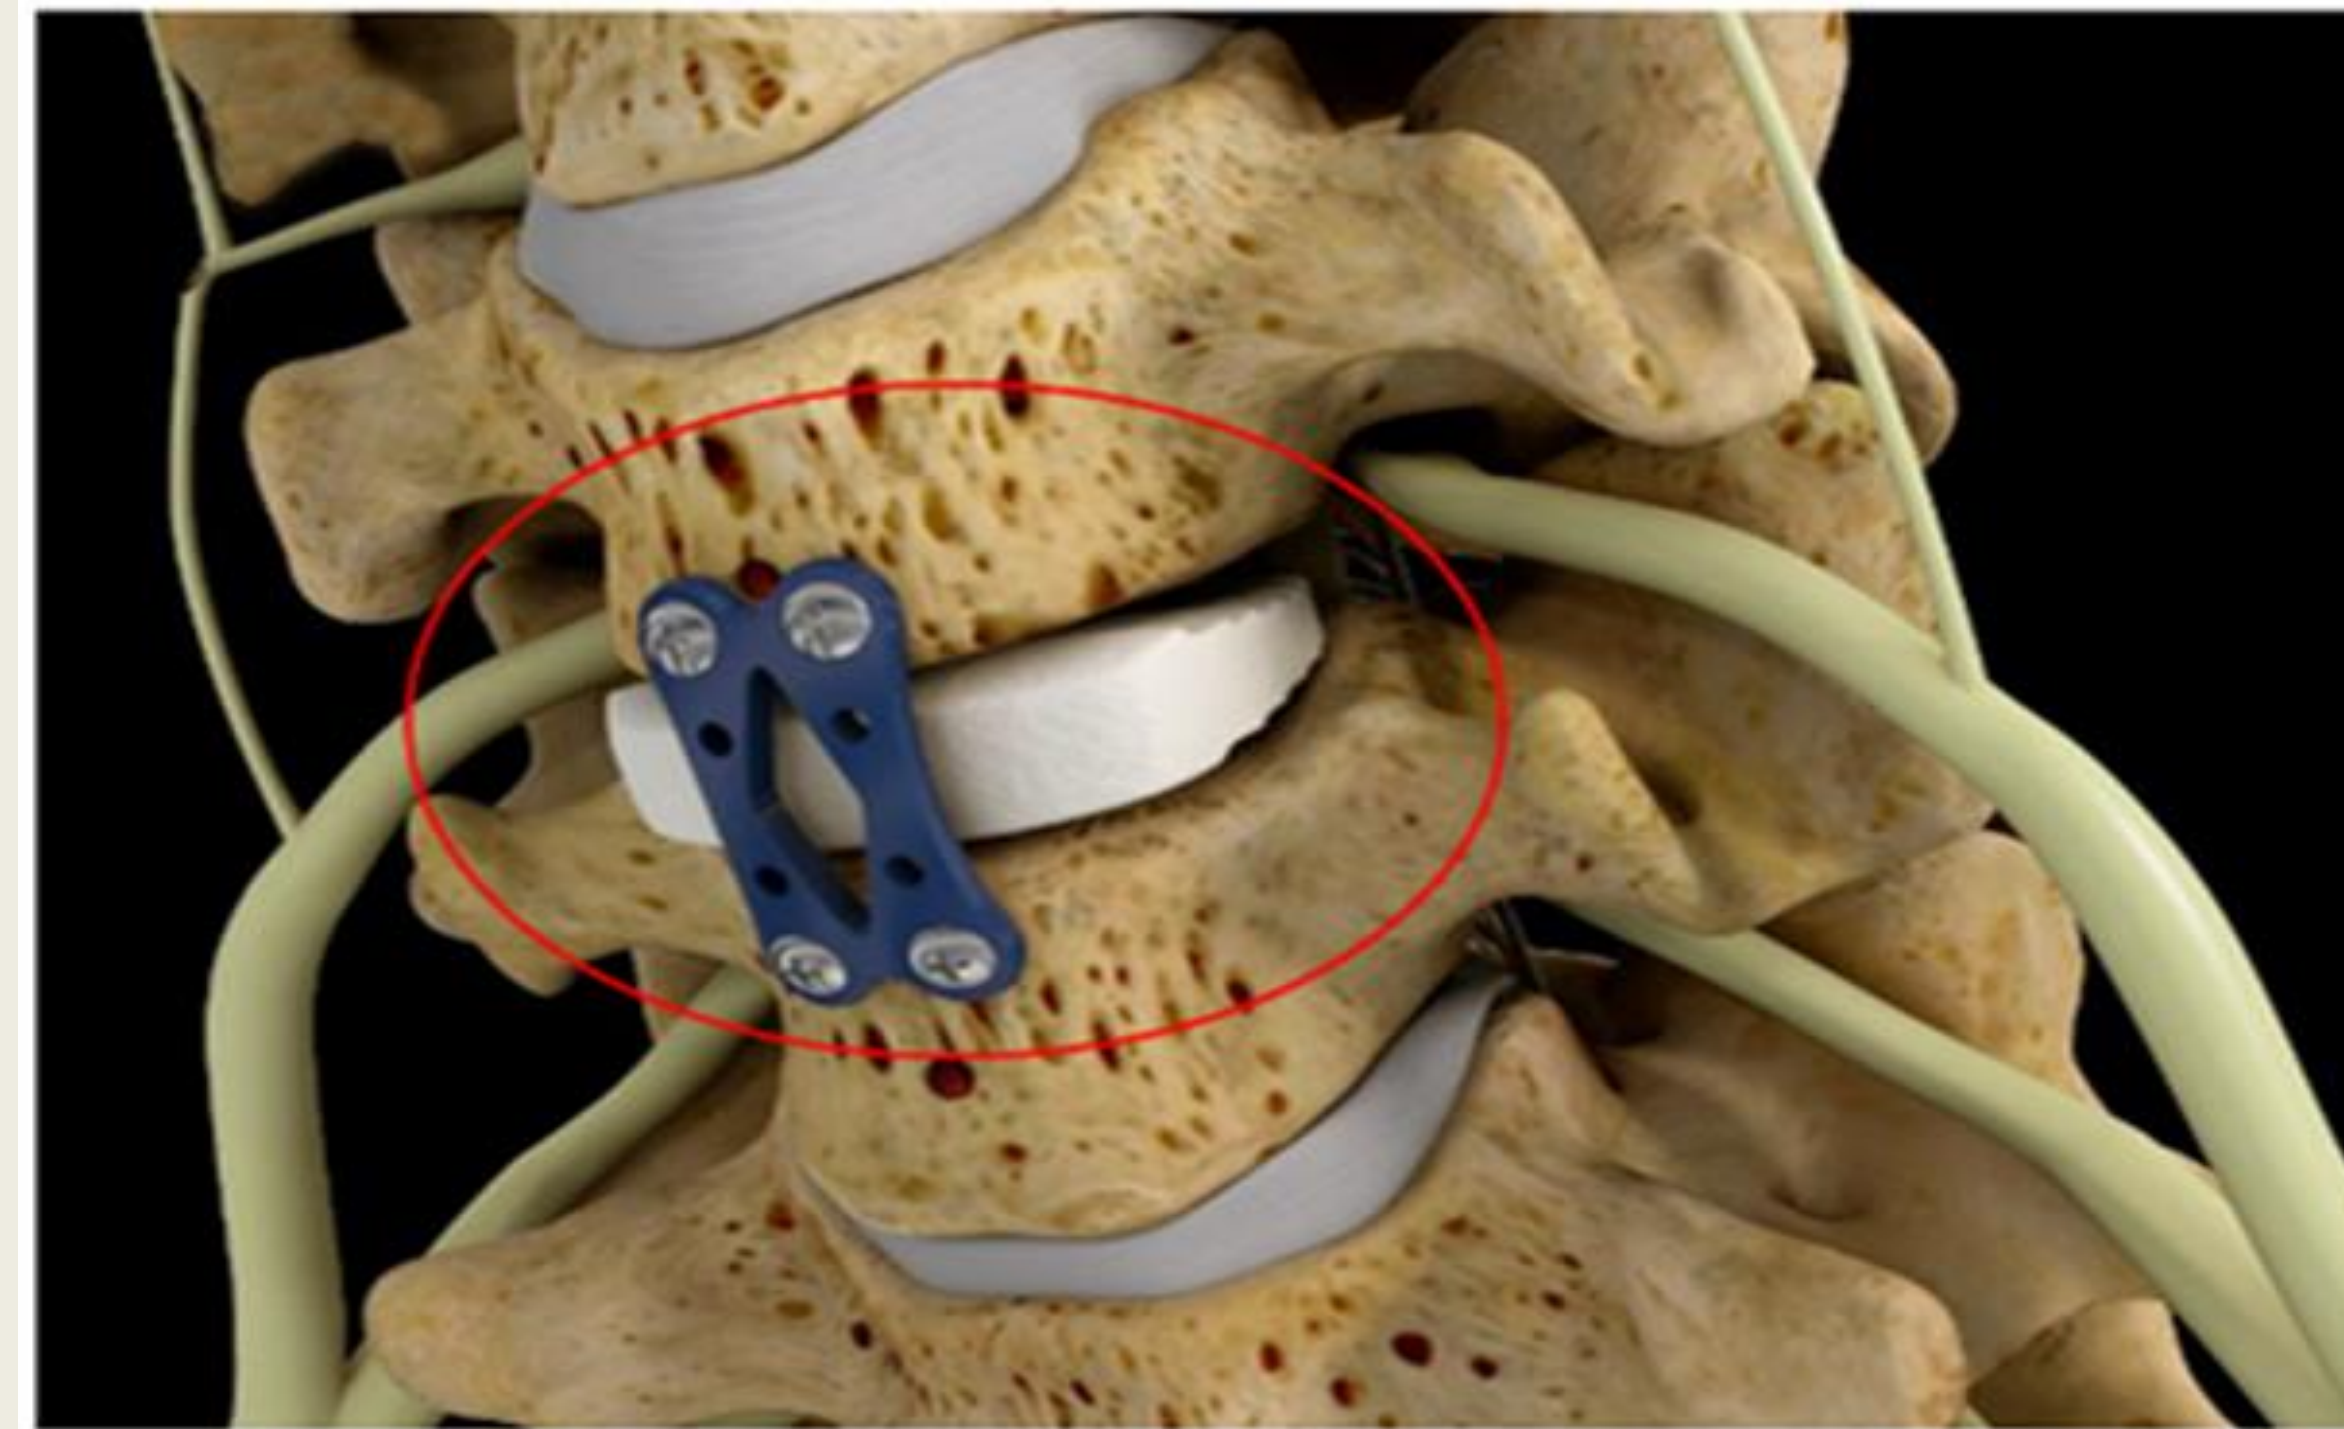
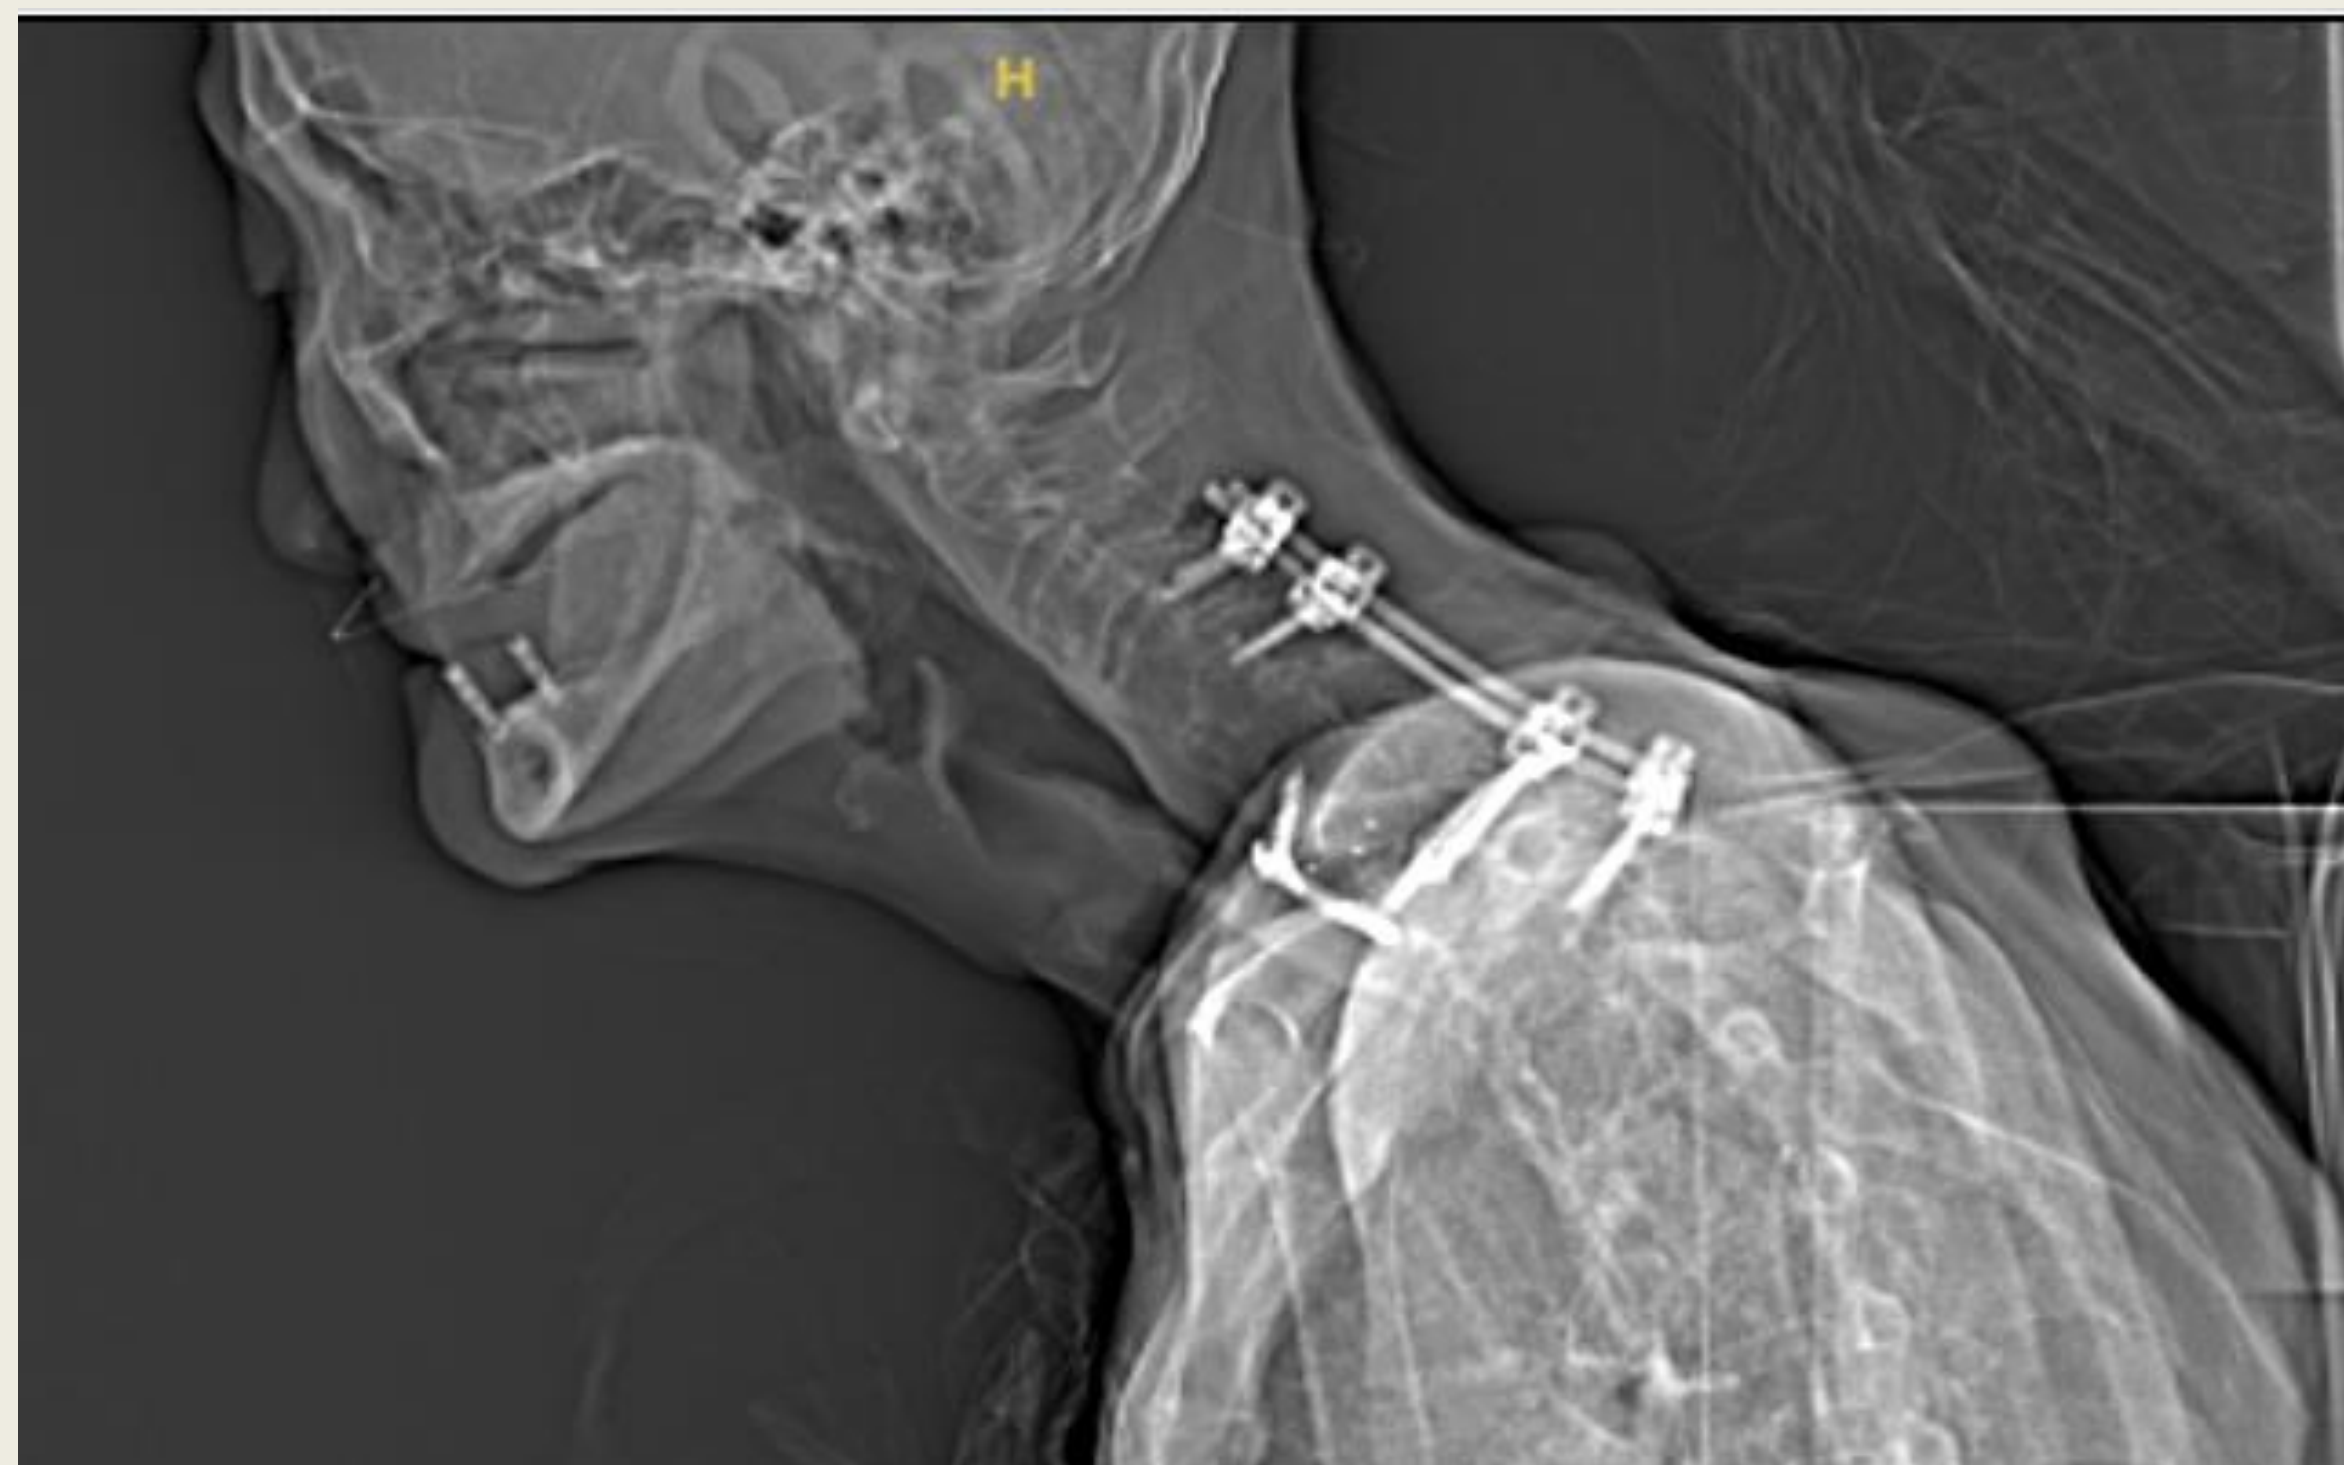
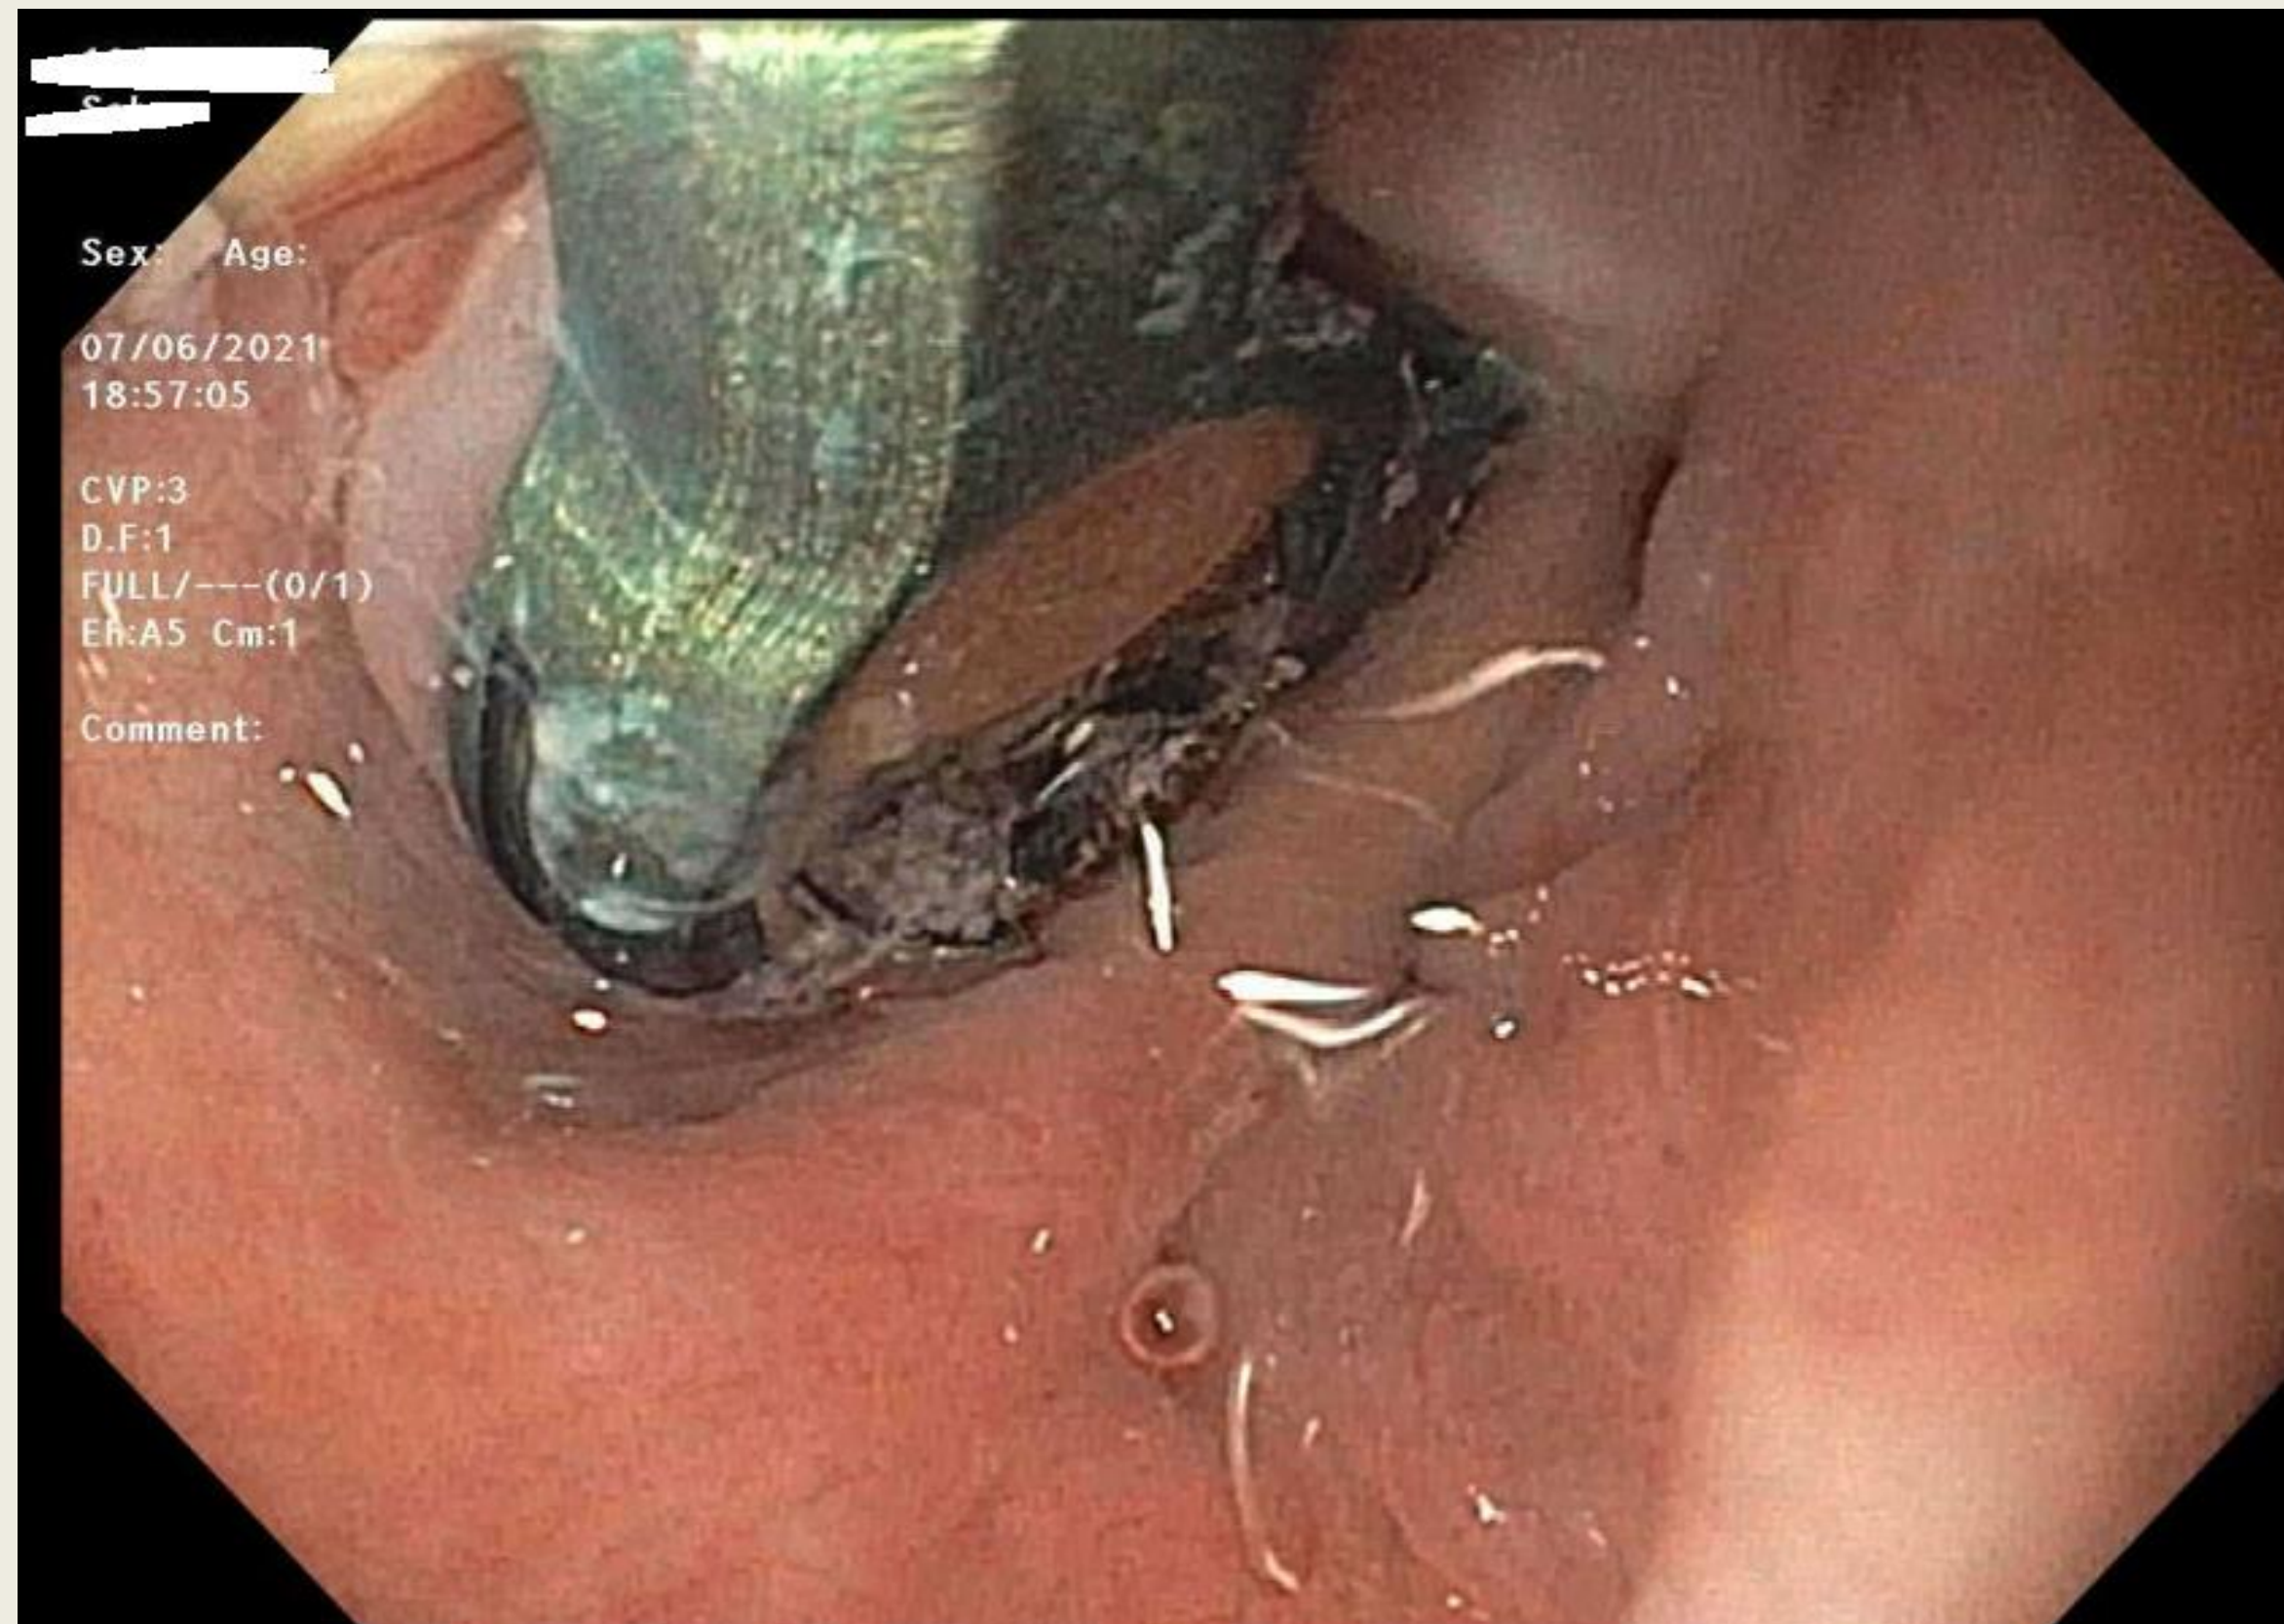
CT SCAN & EGD IMAGES

Esophagogastroduodenoscopy (EGD) did not show any significant pathology in the stomach, but did show a foreign metal hardware (cervical plate) embedded in the wall of the hypopharynx and eroding out.

CT cervical spine showed a fracture of the right C6 anterior fusion screw with evidence of anterior displacement of the fusion plate with 4 to 5 mm gap between the plate and the anterior margin of C6. Disc spacer material appears to extend beyond the anterior margin of the C6-7 disc space.
