Detection and Management of an Intact Splenic Artery Branch Within a Pancreatic Pseudocyst During EUS-Guided Cystogastrostomy

Sanjita Gowda, BS¹; Samuel Ji, DO²; Amirali Tavangar, MD³; Marc Monachese, MD³; John Lee, MD³; Jason Samarasena, MD³

³Digestive Health Institute, University of California Irvine Medical Center

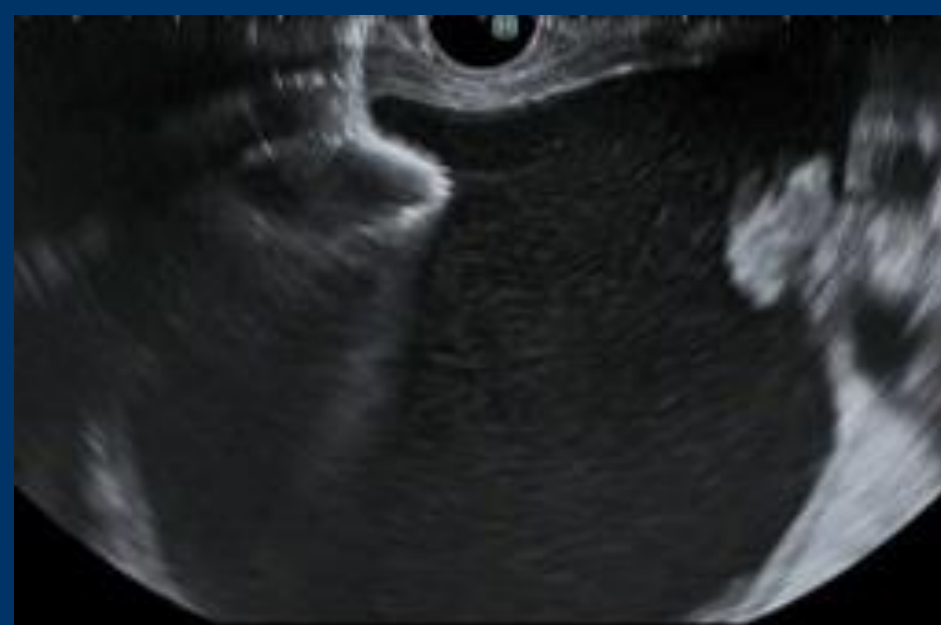
Figure 1: Initial EUS prior to PFC drainage

- Initial EUS demonstrated chronic pancreatitis along with an adjacent large fluid collection with surrounding collateral vessels. As flow doppler did not reveal internal vasculature (Figure 1), a lumen-apposing metal stent (LAMS) was placed and dilated.

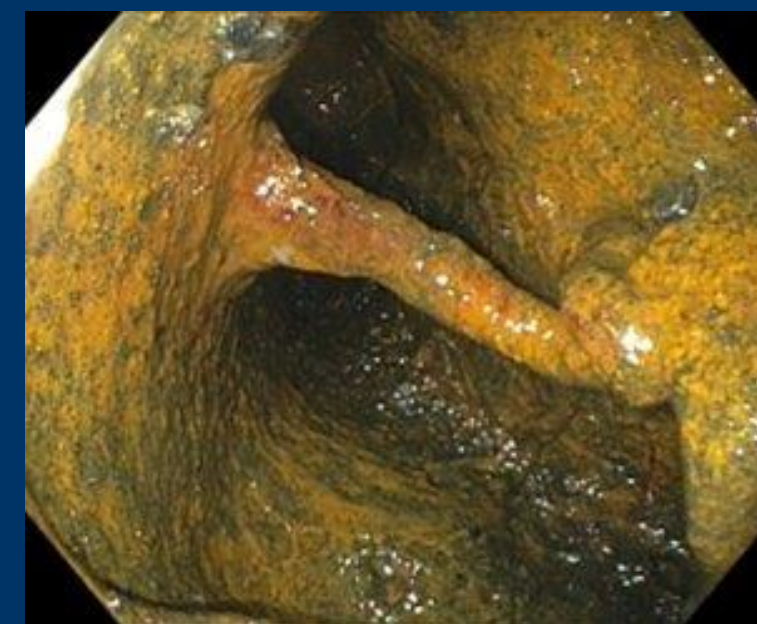
Figure 2: Initial visualization of splenic artery branch within PFC

- Upon entry with the endoscope, a very large vessel was visualized (Figure 2). Repeat EUS revealed an 8 mm vessel with notable pulsation (Figure 3).
- Following consultation with the hepatobiliary surgery service and repeat review of CTAP, the team determined that this vessel was a distal branch of the splenic artery.

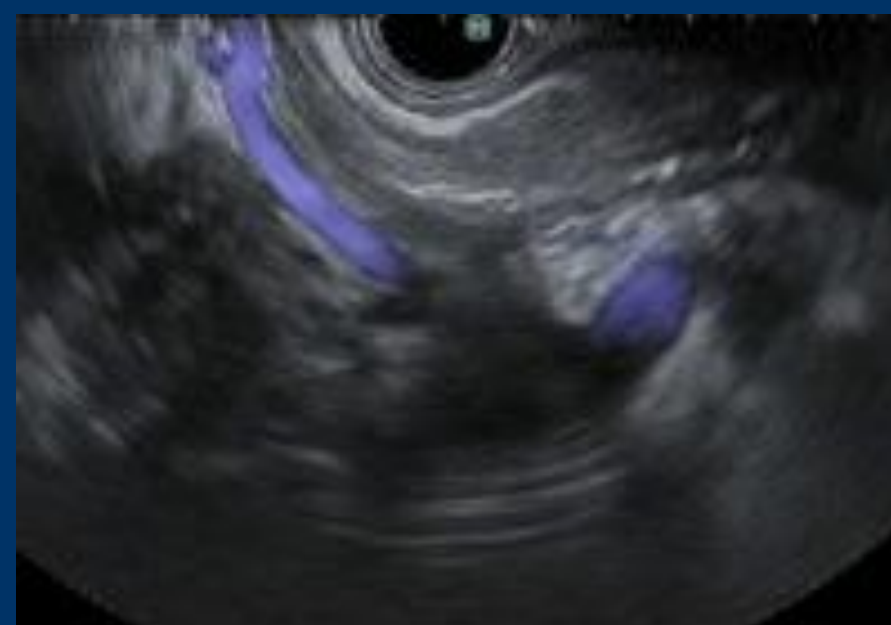
Figure 3: Repeat EUS with Doppler after insufflation of collapsed pseudocyst demonstrating intact vessel

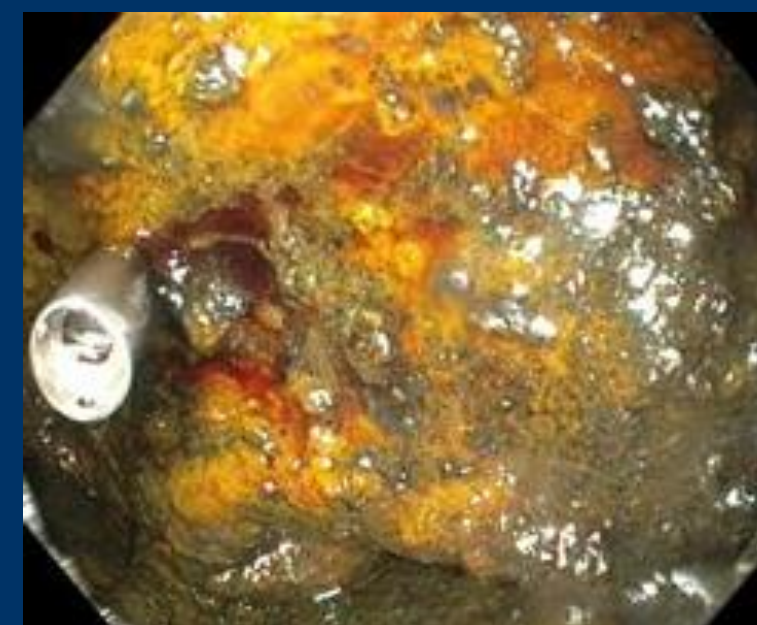
Figure 4: Conmed clip placement to assist in IR localization of vessel origin

- An 11 mm Conmed clip was then placed at the origin of the vessel for interventional radiological localization (Figure 4). The LAMS was removed, and the tract was closed to prevent the risk of catastrophic hemorrhage.

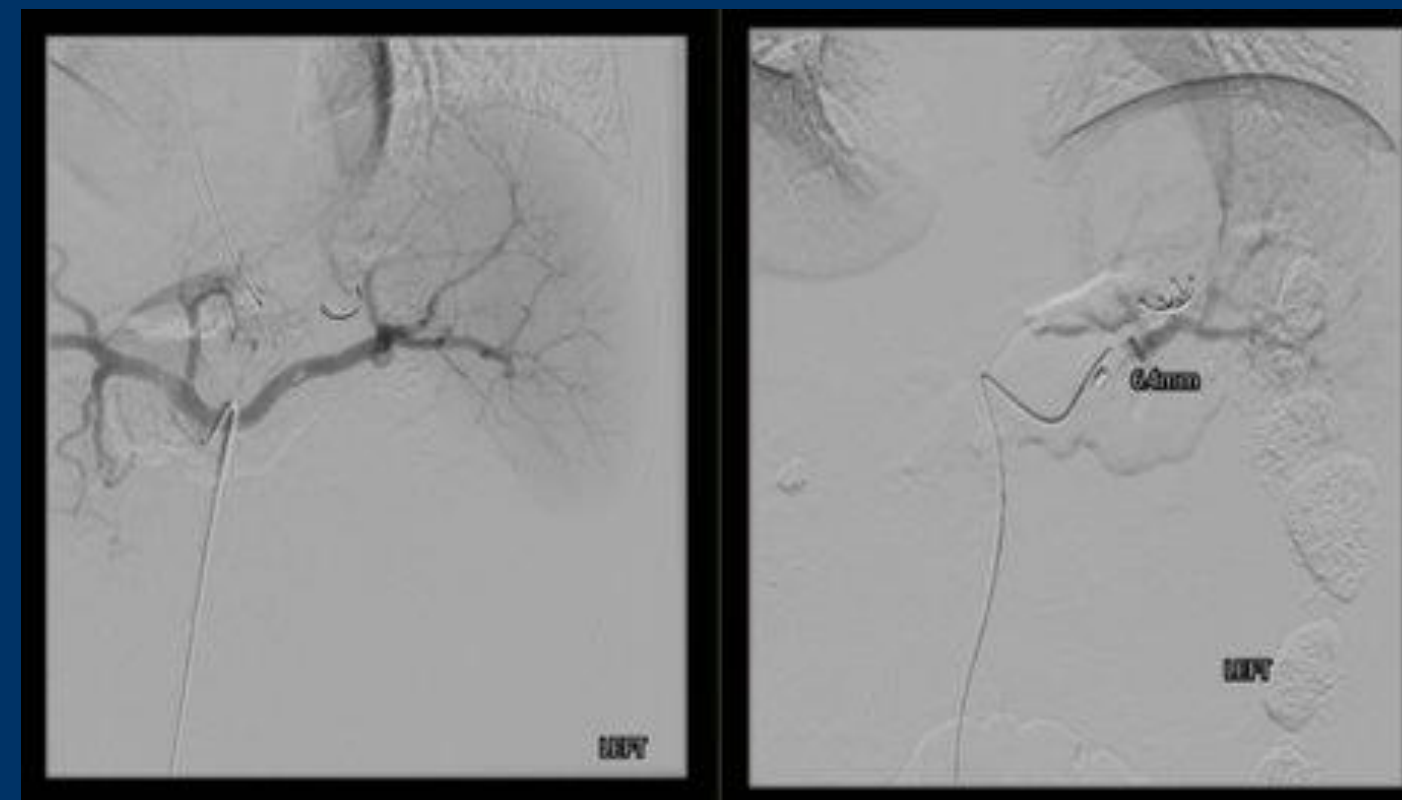
Figure 5. Angiogram of splenic artery branch before (left) and after (right) arterial embolization

- Interventional radiology performed arterial embolization of the splenic artery with subsequent angiogram revealing occlusion of the artery (Figure 5).
- Subsequent EUS and gastroscopic visualization revealed negative flow on Doppler ultrasonography and no evidence of active bleeding, respectively. A LAMS and two double pigtail stents were replaced successfully to address the pseudocyst.
- The patient tolerated the procedures well and was transferred back to the referring facility after three days of admission.
