ontinueCARE Hospital at Hendrick Medical Center

Time Doesn't Heal All Wounds, Quality Patient Care Does: Driving Treatment Measures and Tracking Progression with Long Wave Infrared Thermography

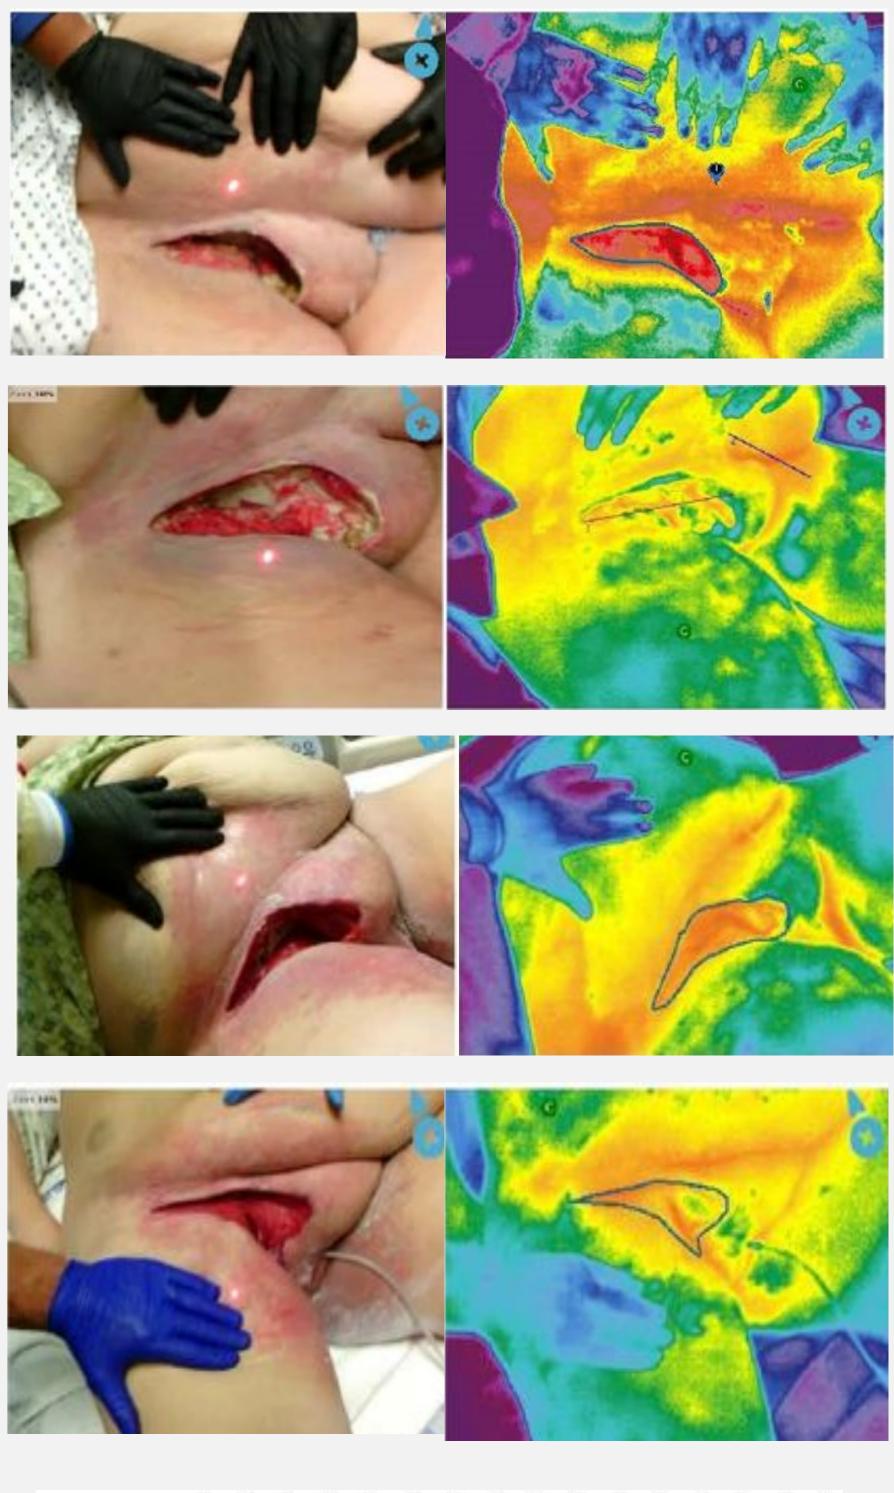
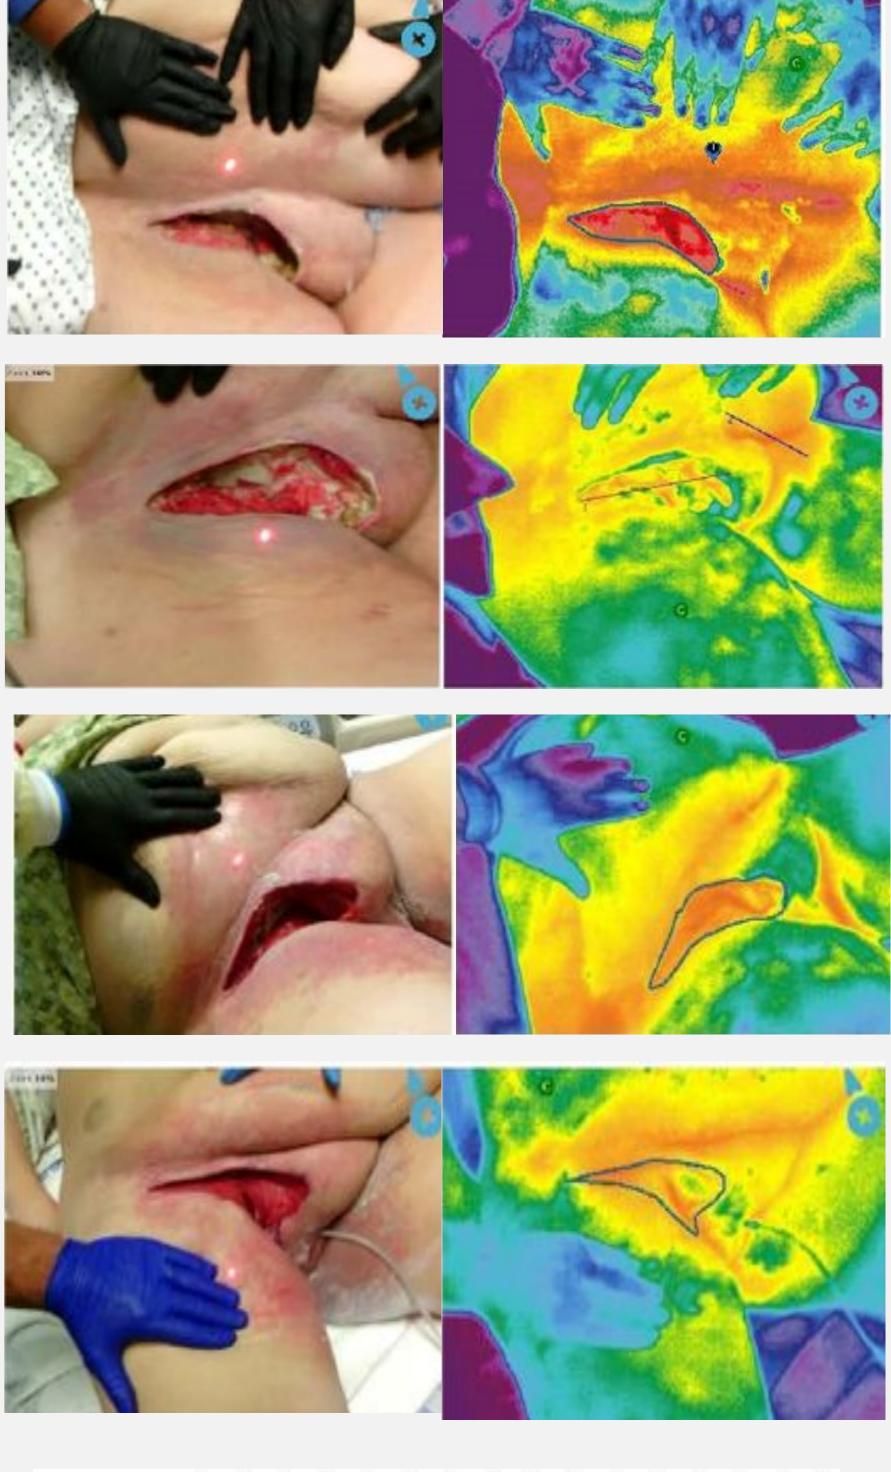
Full Thickness Gluteal Wound:

On admission wound bed with 25% slough with exposed necrosed muscle and adipose tissue. On discharge, wound was >75% granulation tissue, spongy and bright red Wound size: Admission: 64.5 sq cm; 9 cm depth Discharge (Day 37): 41.9 sq cm; 5 cm depth 35.1% reduction in size and 44.4% reduction in depth Thermography: Admission max temperature: 4.1°C Discharge (day 37) max temperature: 2.3°C 43.9% decrease in temperature to normal range (+1.1 C to -1.1 C)

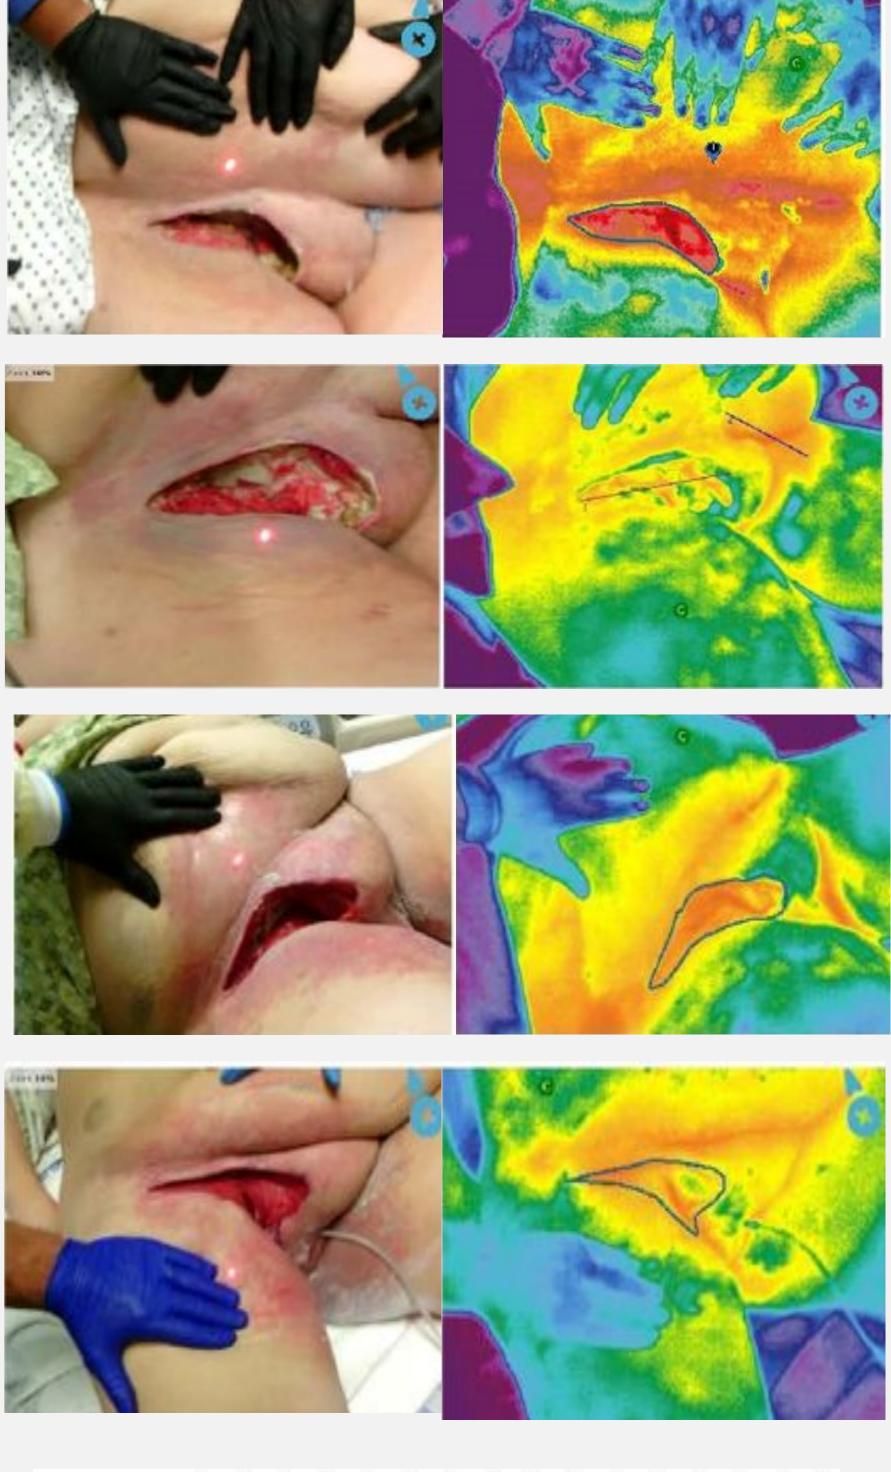
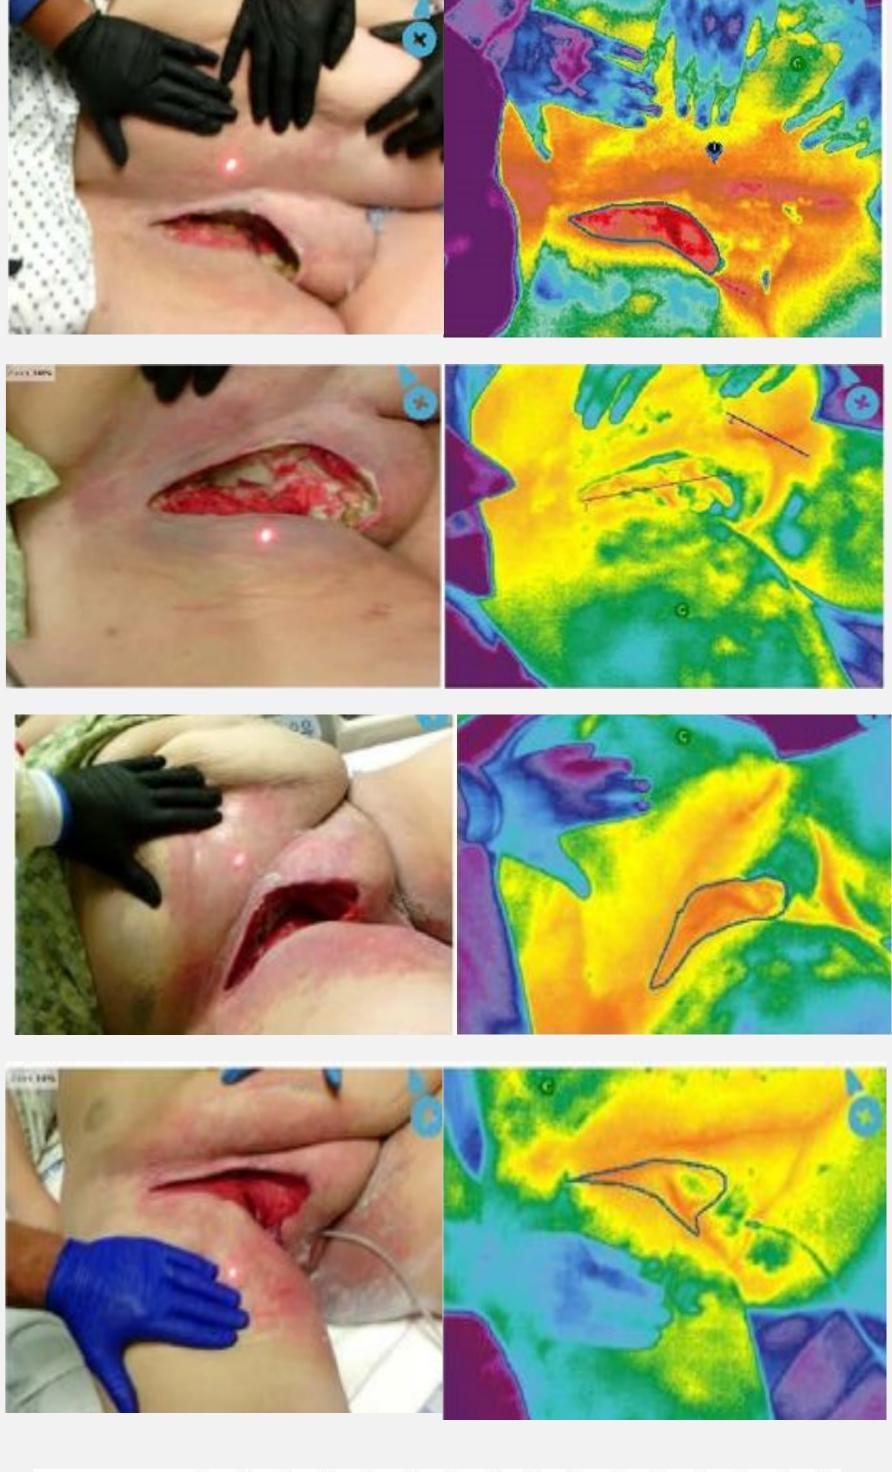
Full Thickness Groin Surgical Wound:

Wound size: Admission: 136 sq cm Discharge (37 days later): 49.5 sq cm 63.6% reduction in wound size

Thermography: Admission minimum temperature: -3.8°C Discharge (day 37) minimum temperature: -1.9°C 50% increase in temperature to normal range (+1.1 C to -1.1 C)
