Assessment of Hard-To-Heal Wounds using Hyperspectral Imaging

A series of three patients with hard-to-heal wounds were imaged using a hyperspectral imaging device. The ensuing images allowed the clinical team to understand the reasons for not healing and modify the treatment accordingly.

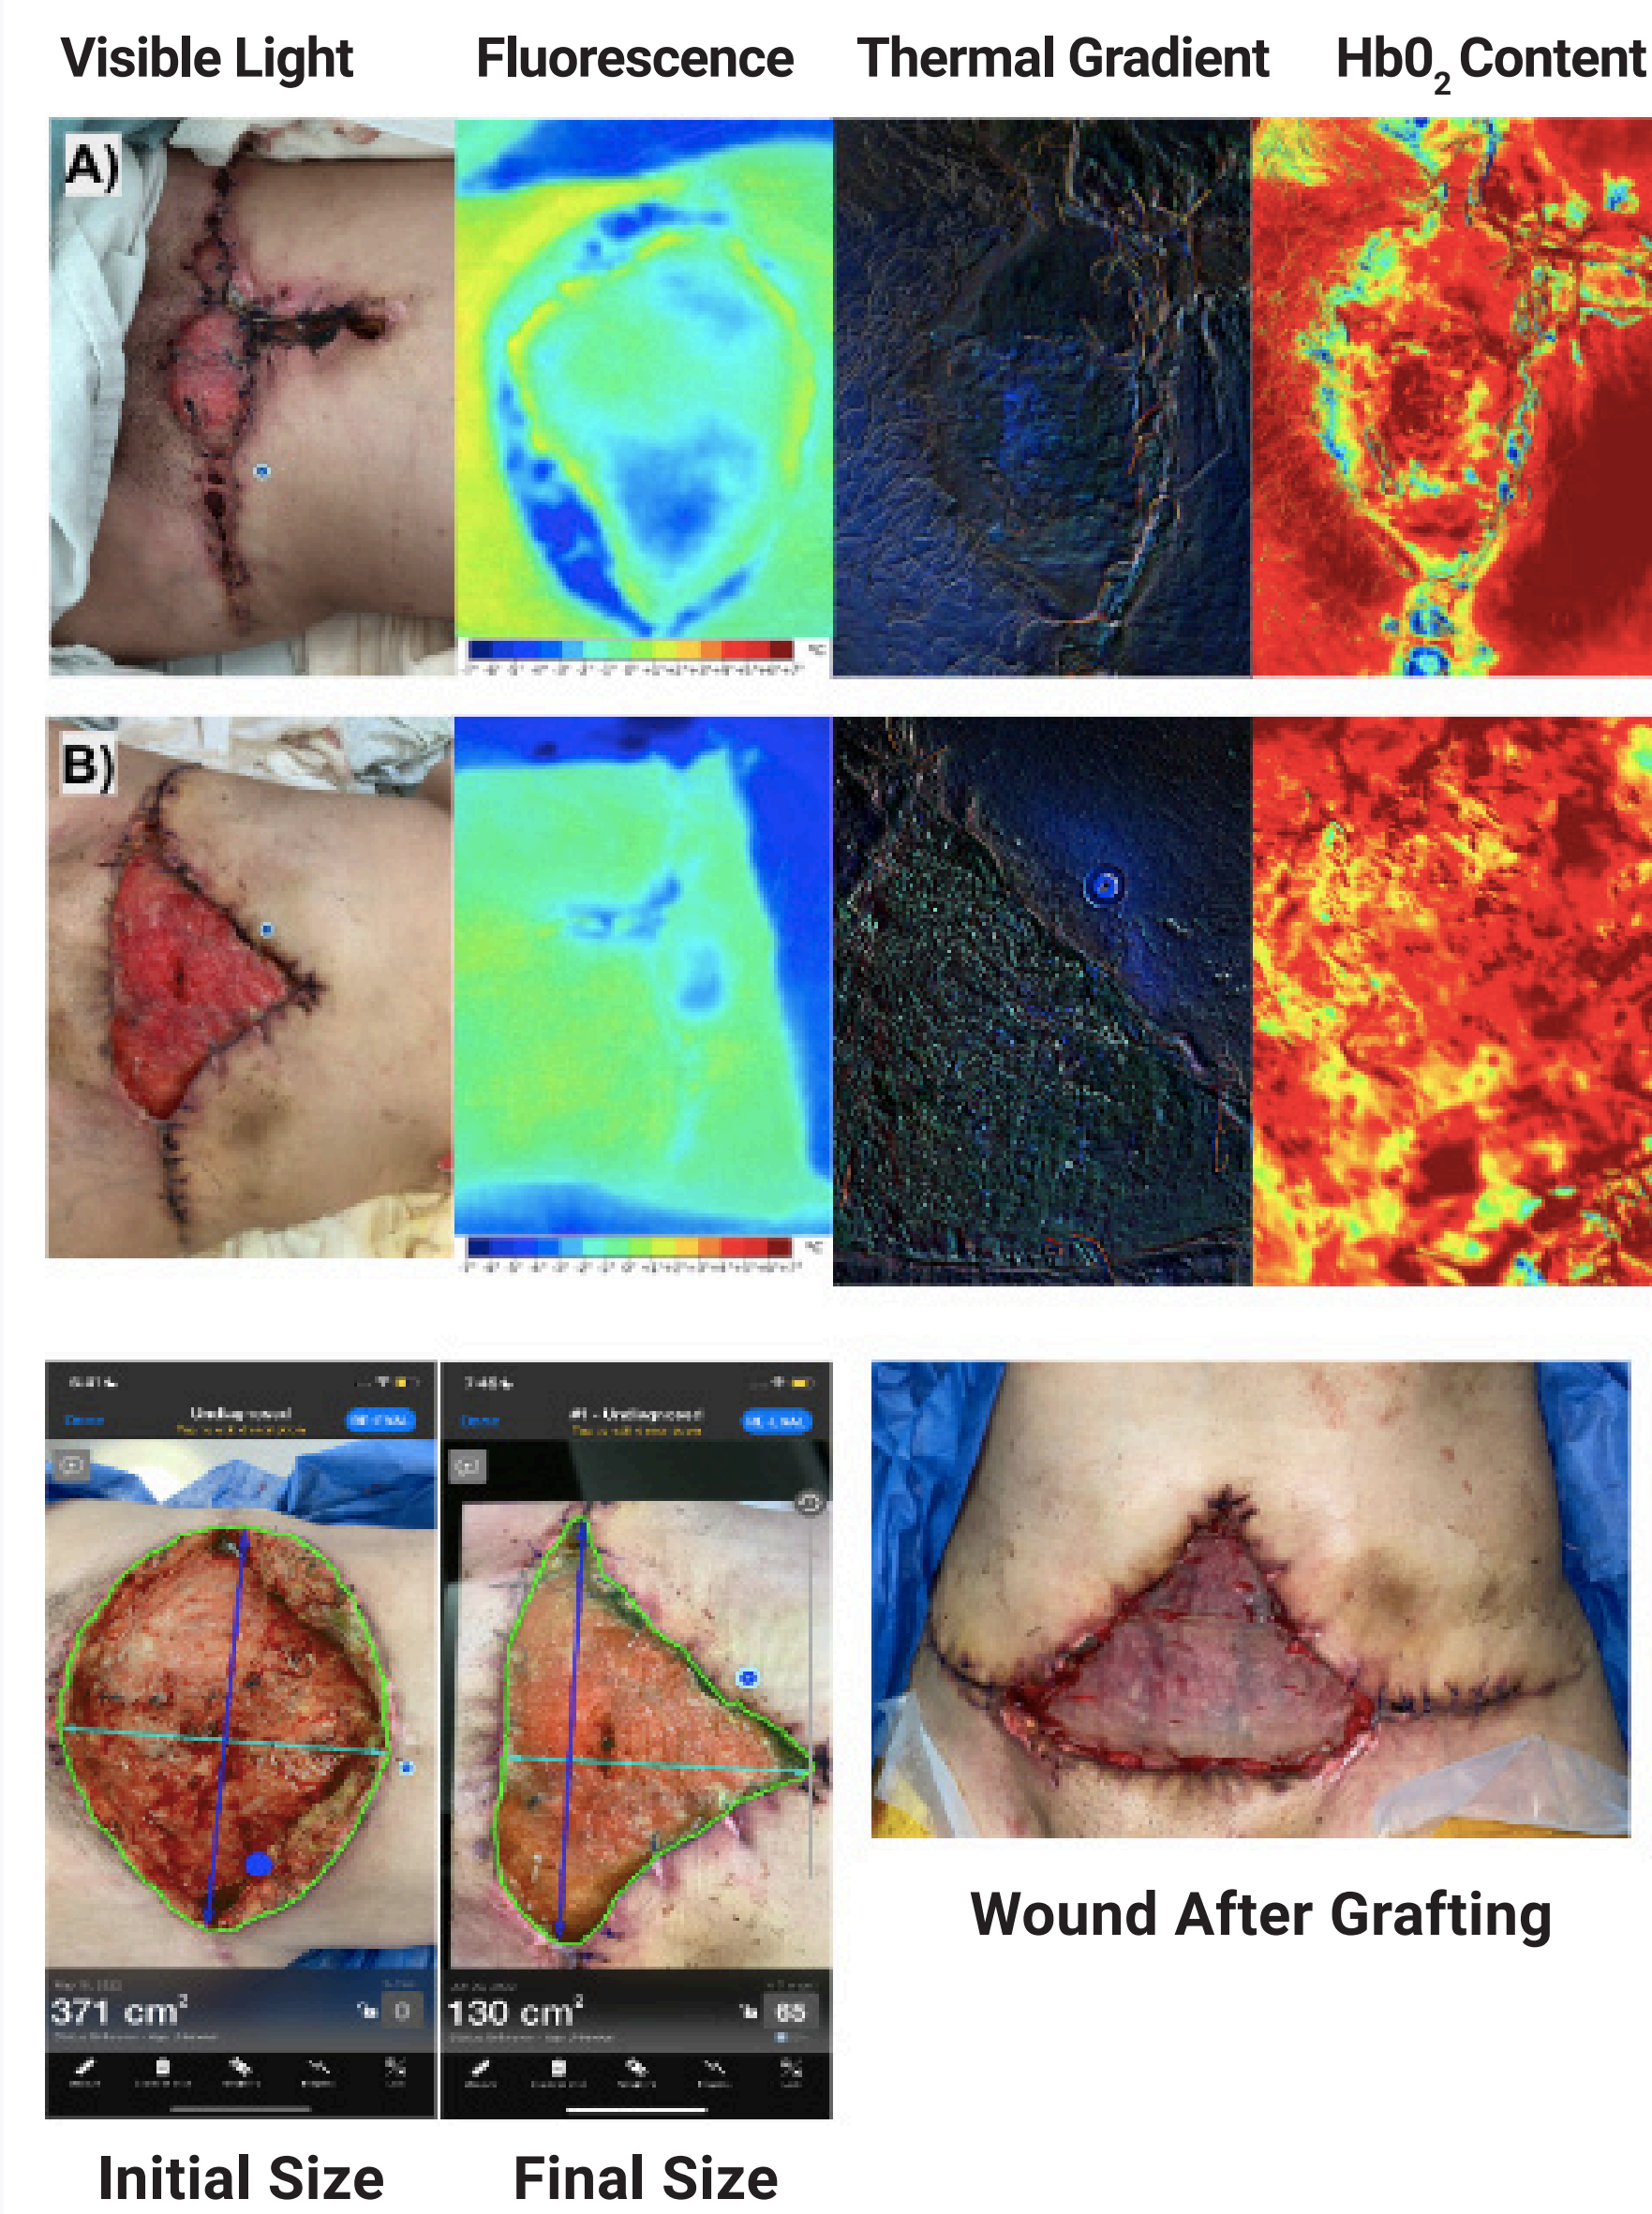
- On presentation, she had a very large open wound covering the surgical site and extensive skin necrosis. HSI imaging ruled out the presence of infection as no bacterial fluorescence nor inflammatory changes were identified (Panel A).

- After 4 weeks of intermittent NPWT, the wound presented significant improvement and the wound was skin grafted (Panel B).
- Throughout the patient's wound journey, HSI imaging helped monitor the lack of tissue bacterial contamination, tissue oxygen levels, and perfusion; paving the way for an efficient planning of the surgical repair of the wound.

- Levine swabbing confirmed the absence of infection in the wound bed or its margins.
- Assessment of tissue viability with IRT and HbO₂ imaging suggested that no further necrosis would be expected.

- The patient was managed with NPWT. The Ray 1 with the rest of Swift Medical's wound management solution, allowing the accurate 3D reconstruction of the wound and enabling volumetric measurements in it (for a video 3D rendering of the wound, scan the QR code).

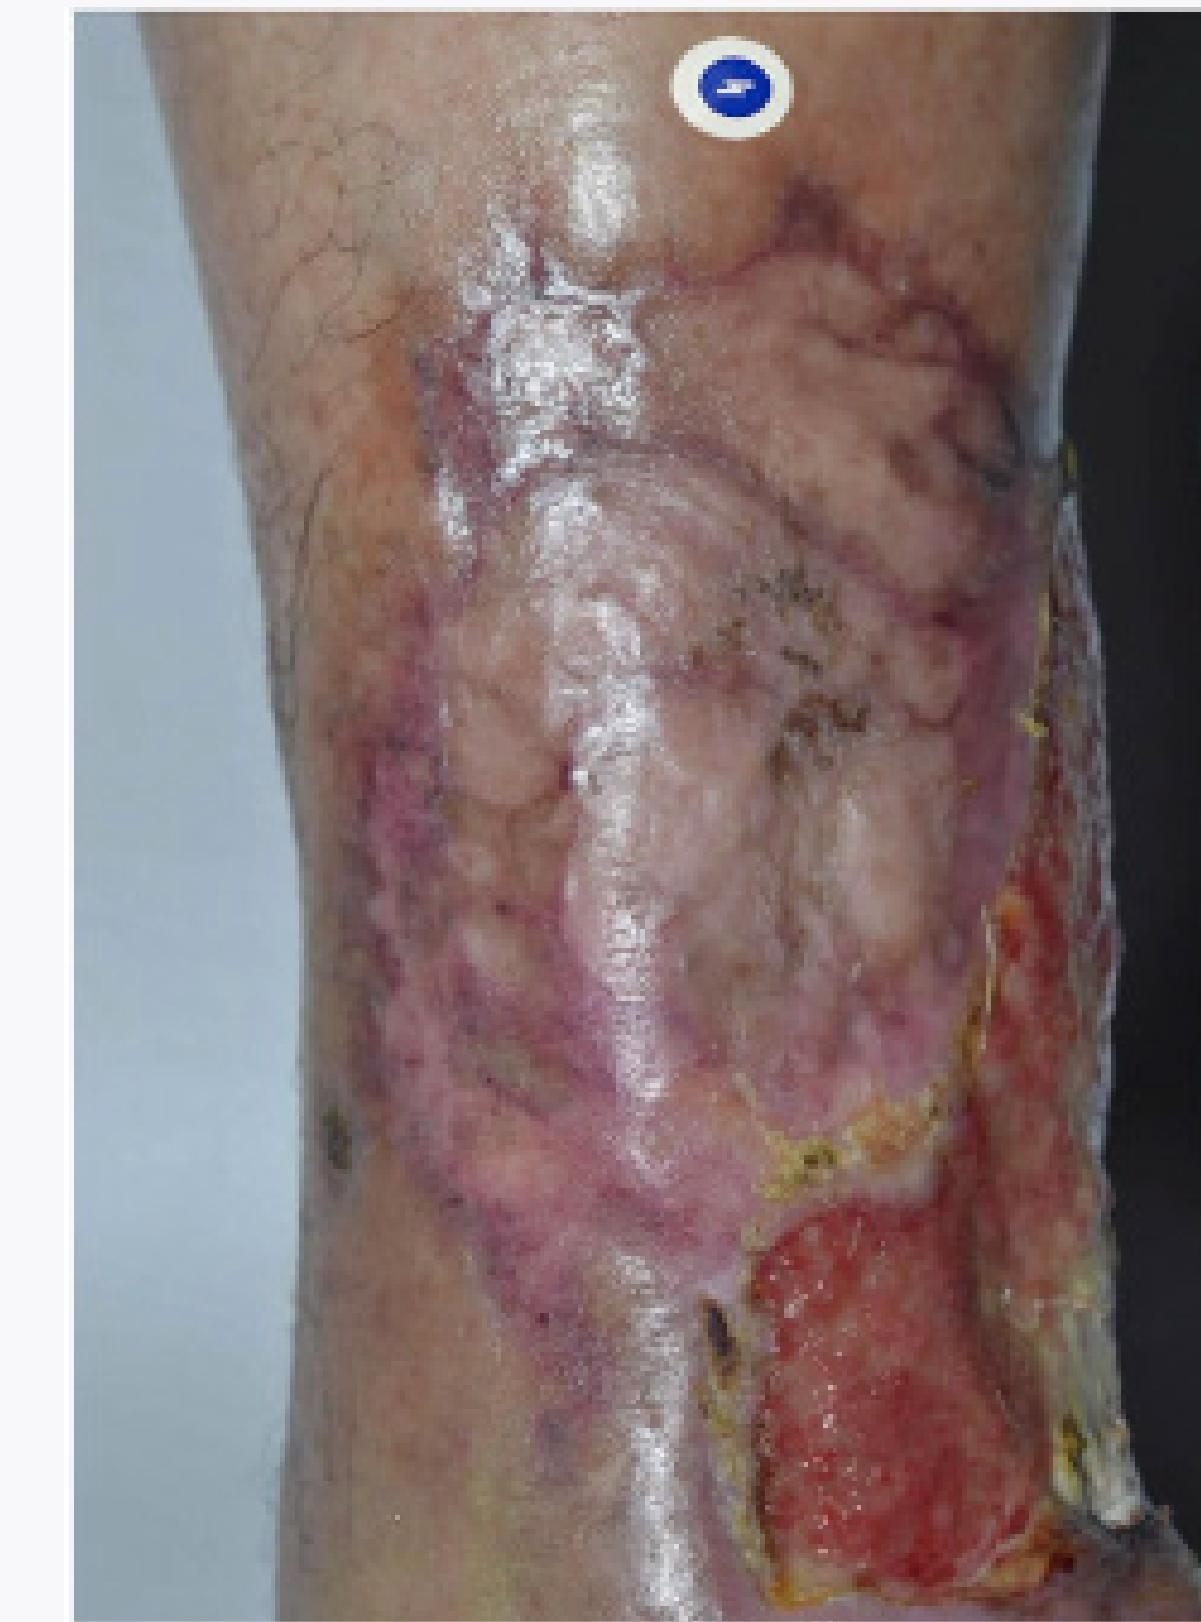
- On initial presentation, the wound presented necrotic borders and a large amount of slough over the granulation tissue; however, bacterial contamination was ruled out through violet light fluorescence. Infrared thermal imaging (IRT) demonstrated a cold wound bed, with a thermal gradient below -3°C, which indicates the need for advanced management. Oxyhemoglobin (HbO₂) imaging correlated the previous findings with a wound bed with relatively low oxygen content (Panel A).

- 4-weeks later, she returned to our clinic because of pain and malodour in the wound. Bacterial fluorescence imaging confirmed the presence of bacteria below the graft and a targeted tissue biopsy was returned positive for E. coli infection. Nonetheless, HSI imaging showed areas of the graft with high oxygen content and temperatures similar to those of healthy skin so the decision to initiate antibiotics and save as much tissue as possible was done (Panel B).

- Resolution of the infection was monitored clinically and by HSI imaging (Panel C).
- After three weeks, HSI monitoring showed resolution of the infection and uptake of the remaining grafts, thus avoiding additional surgical procedures (Panel D).

- After debridement and preparing the wound bed for 15 days, the ulcer was grafted with autologous skin; however, the patient was lost to follow-up, as she lived in a rural community.
