Use Of A Bioresorbable Silver Matrix and NPWT To Treat A Failed Full-thickness Skin Graft Site

Amanda Murray, NP-C, MSN, WCC
Great Falls Clinic Wound Care Center, Great Falls, Montana

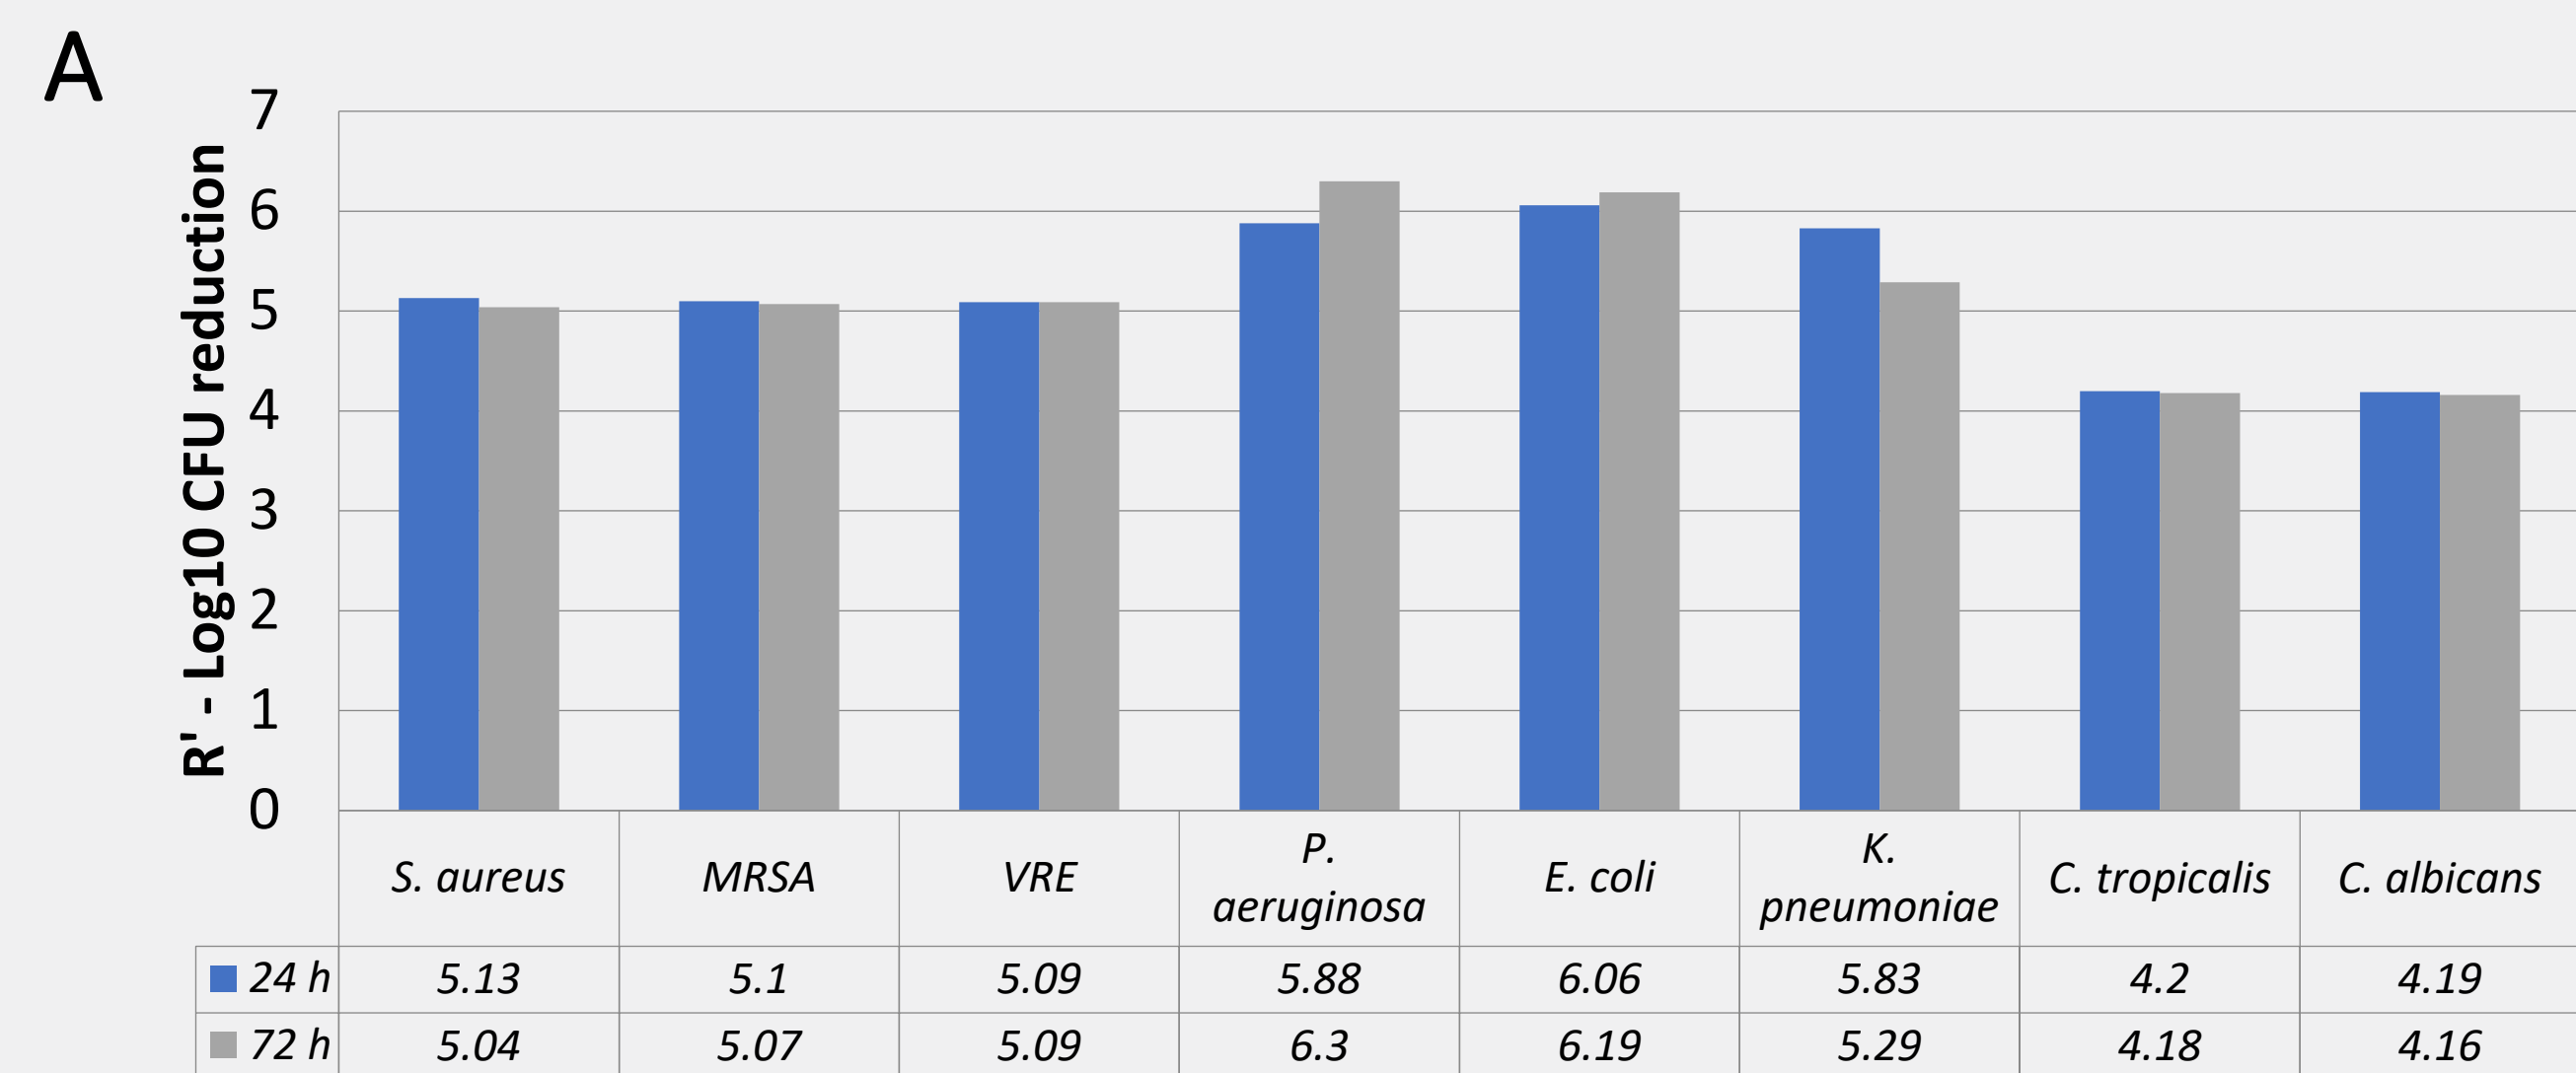
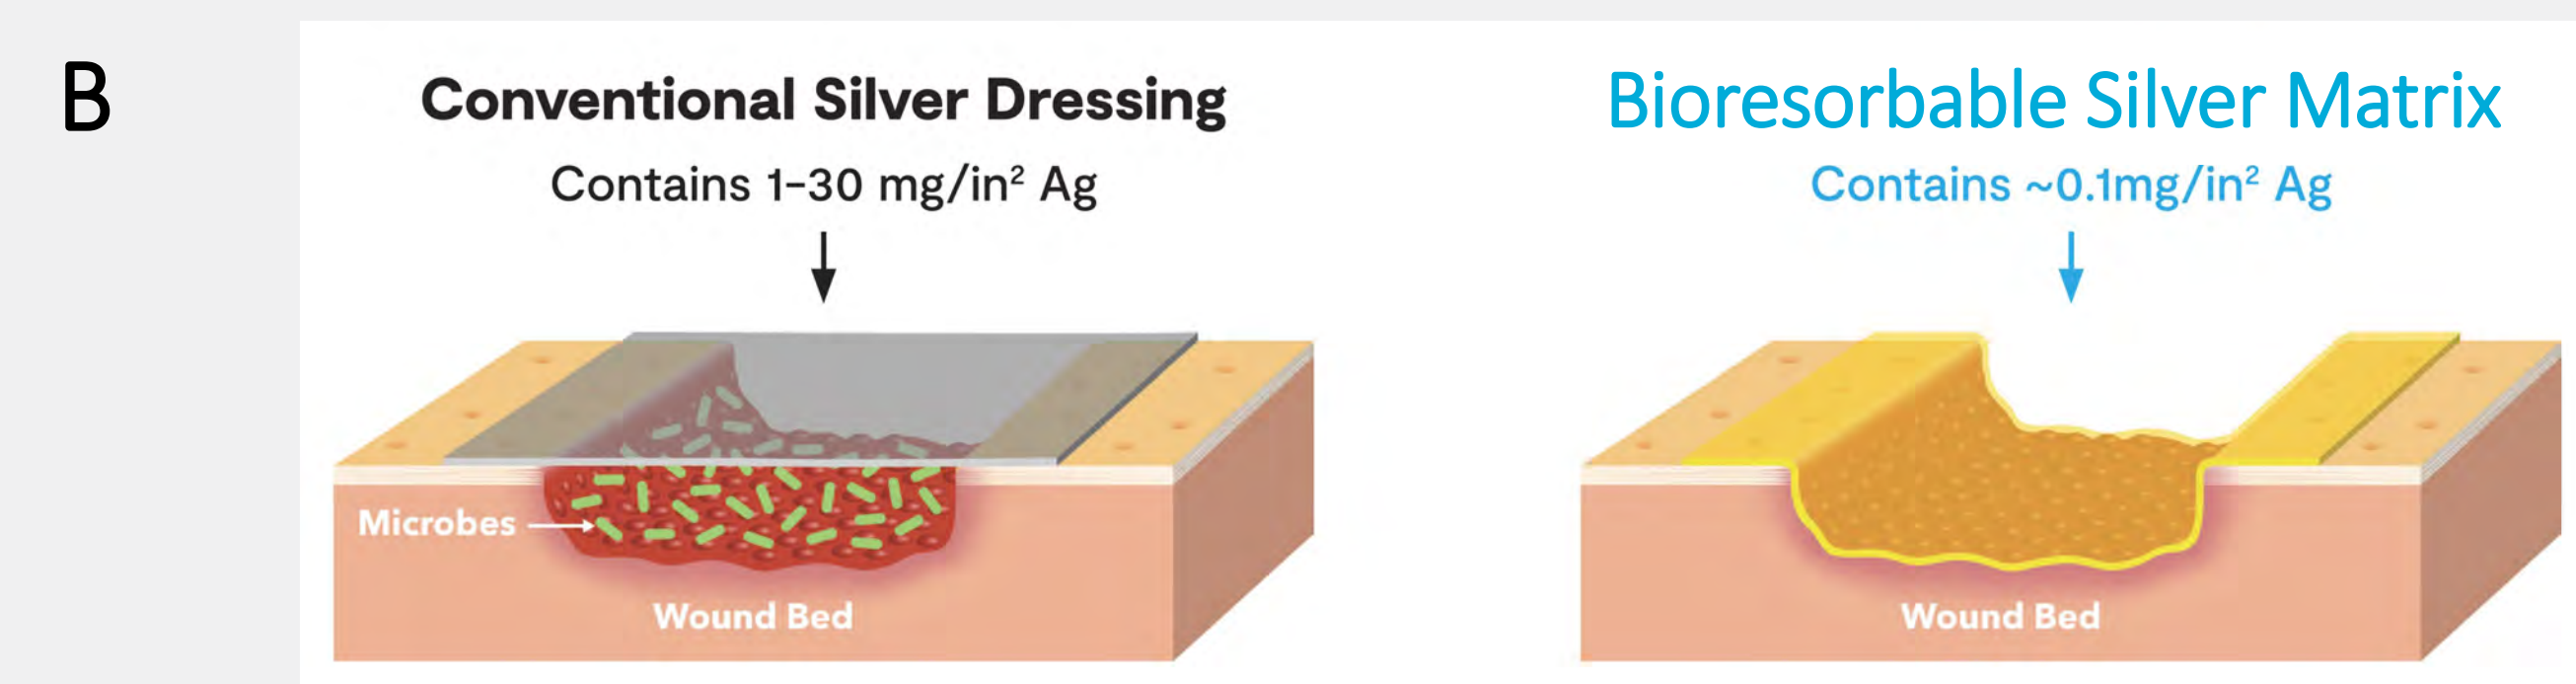
Figure 1: A) The Matrix provides a 4- to 6-log reduction in a variety of bacteria and yeast, including MRSA and VRE.^{2,3} B) Mechanism of action of a bioresorbable silver matrix. Unlike conventional silver dressings, the Matrix contours to the micro-texture of the wound bed allowing active ingredients to be effective at low doses.⁴ C) The mechanism of action of the Matrix is designed to facilitate improved wound healing.⁴

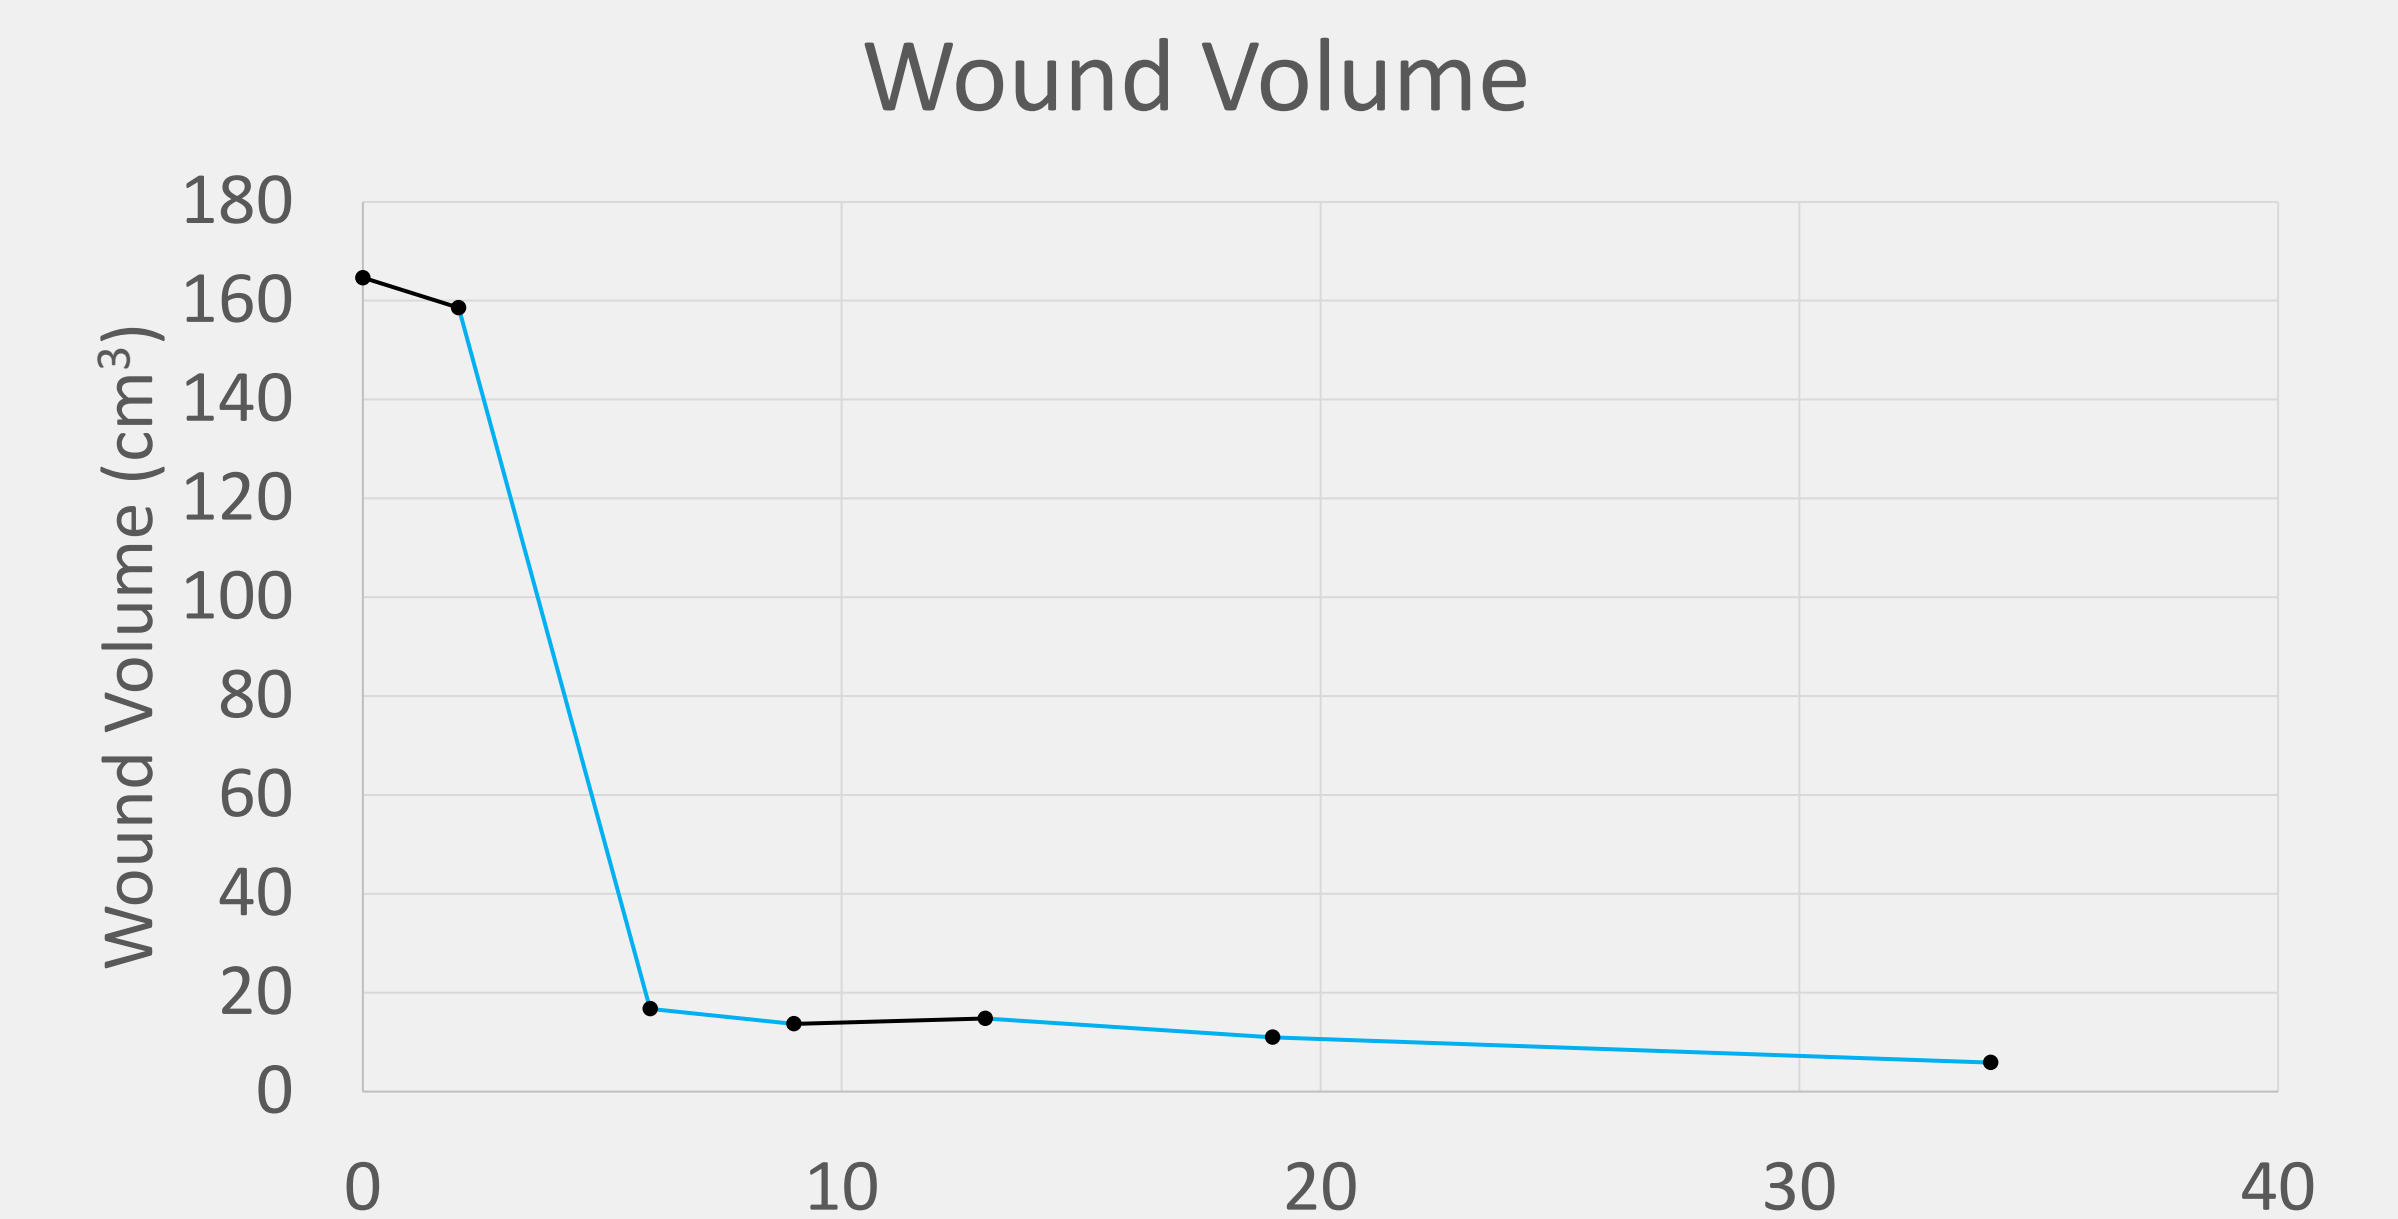
Figure 3: The healing trajectory of the wound over 5 weeks. Bright blue lines indicate period of Microfilm Matrix application.

After just four days of Microfilm Matrix and NPWT treatment, the patient's wound decreased by an astonishing 90%. At week 4, her wound was 96% healed and 100% healed by week 5.
