ArcGuide™ Lightning Protection Coating

MOTIVATION

ArcGuide™

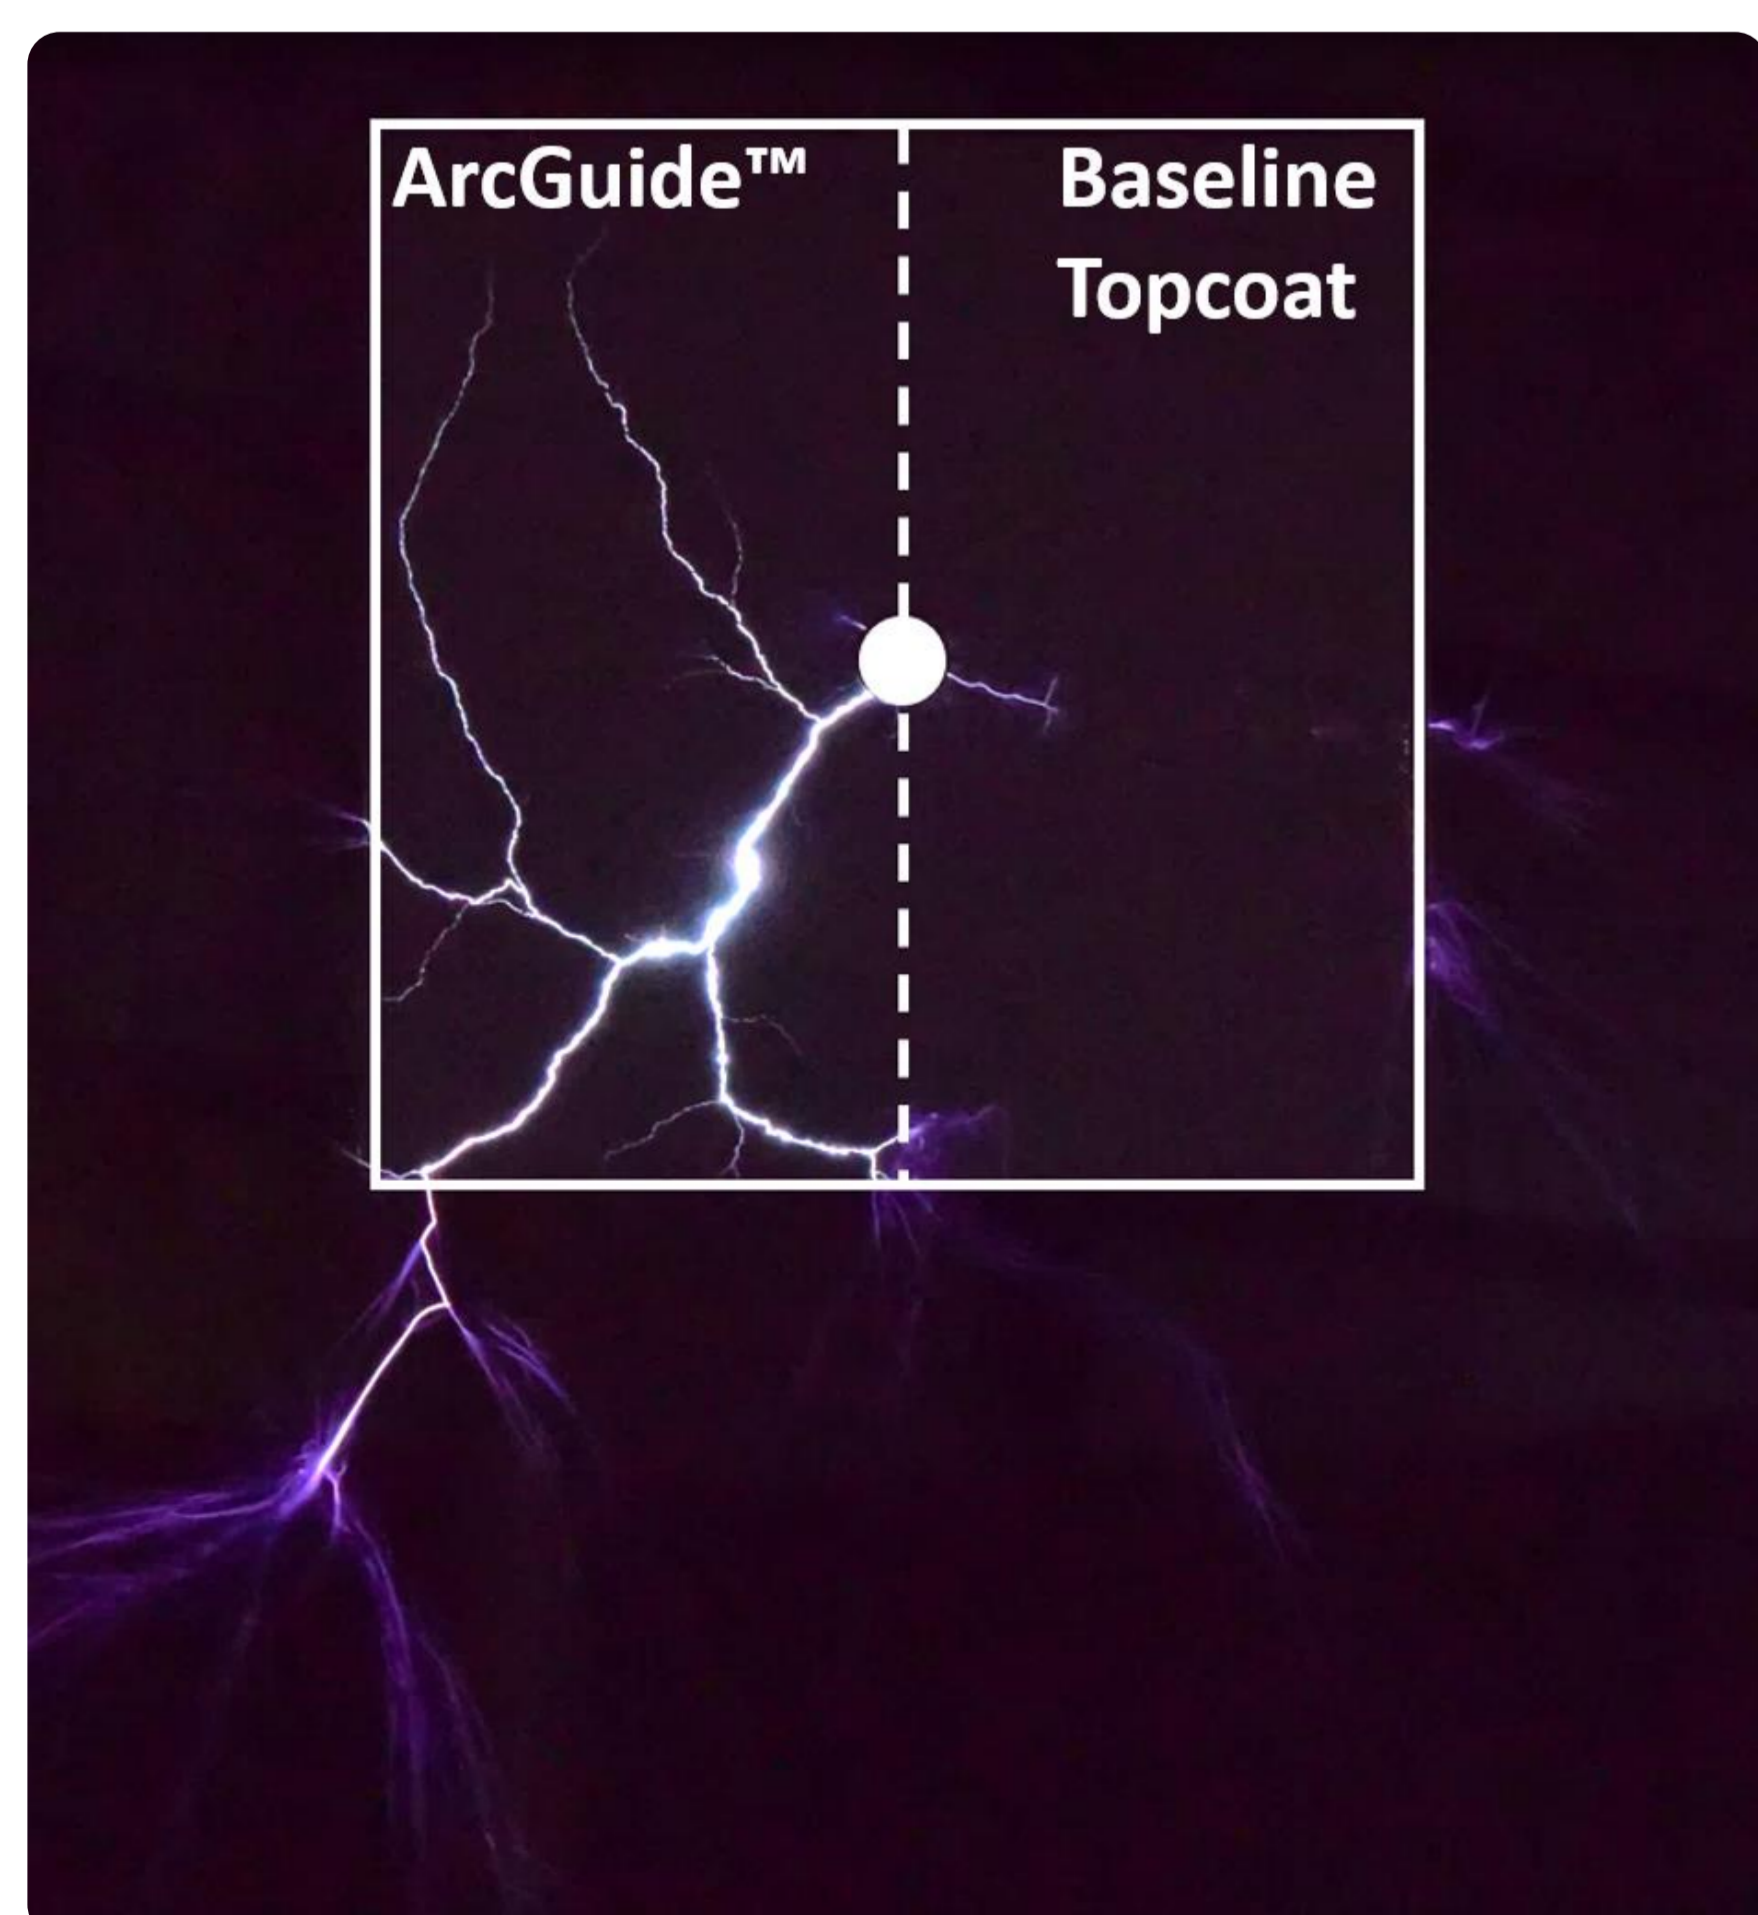
- A novel coating to enhance the performance of existing lightning protection systems.
- Industry standard topcoat mixed with a proprietary formulation of small conductive particles.
- Enhances the electric field in the air adjacent to the coating, facilitating early streamer and leader formation along the surface to the lightning receptors.
- Not damaged by full-threat (200kA) lightning currents.

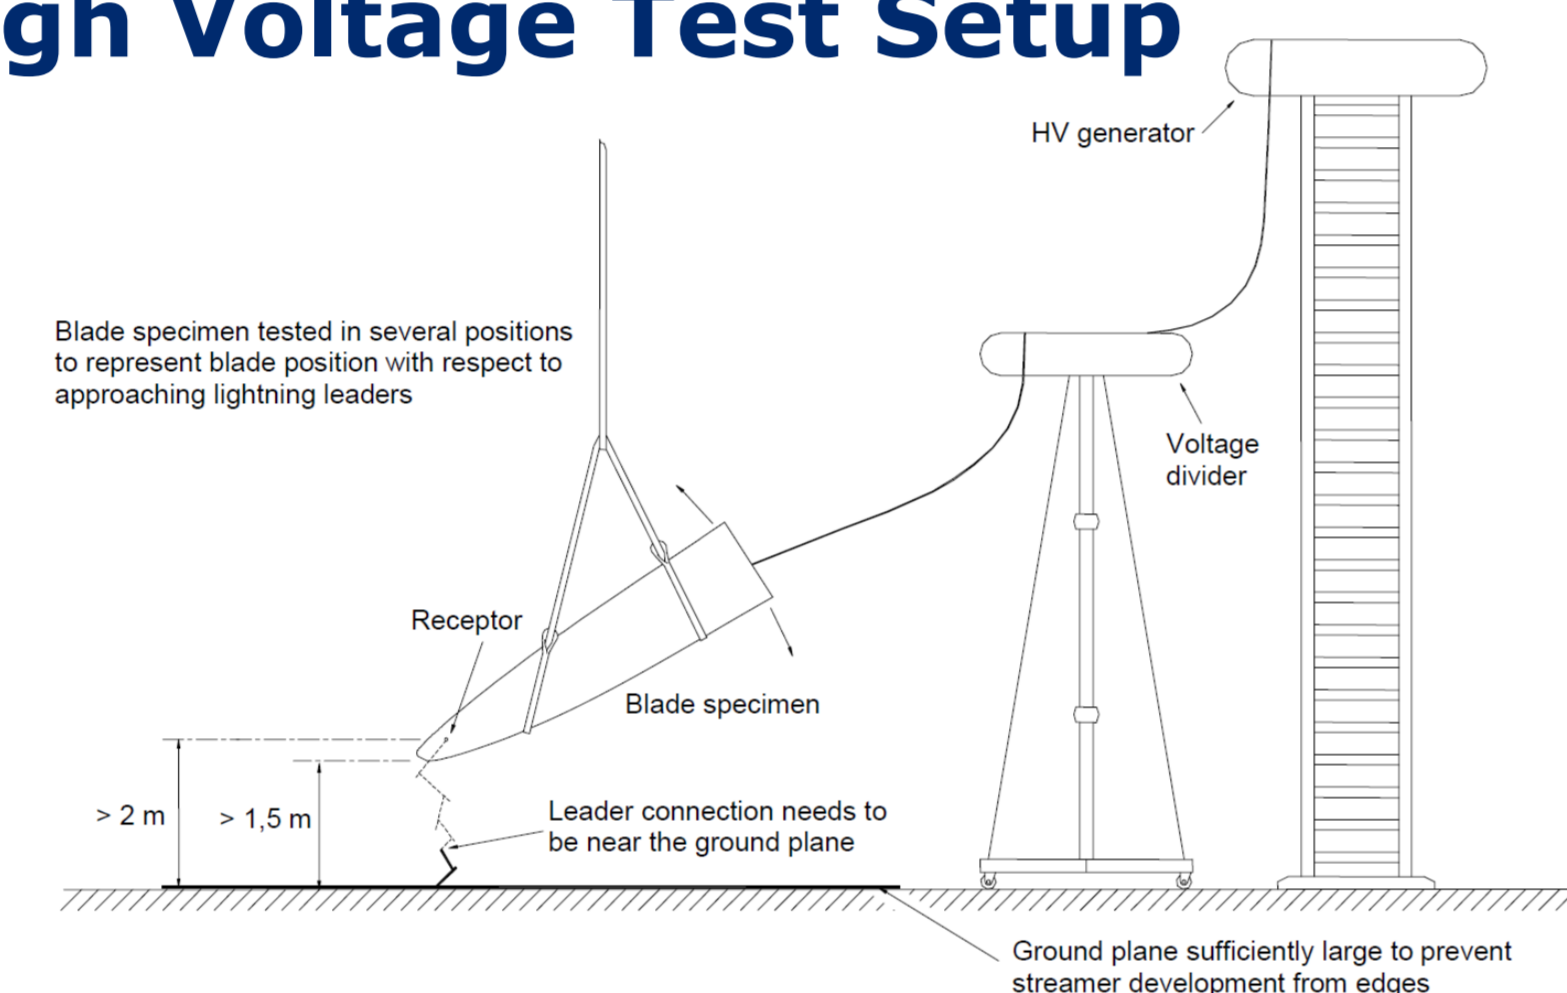
High Voltage Test Setup

Compared field-used blades with and without ArcGuide™ using high voltage initial leader attachment tests (IEC 61400-24)^[2]

- 3 blades (GE 37C)
- 2 configurations: ArcGuide™ & baseline
- 3 angles: 60°, 30°, and 10°
- 3-4 orientations per angle
- 3 strikes per orientation

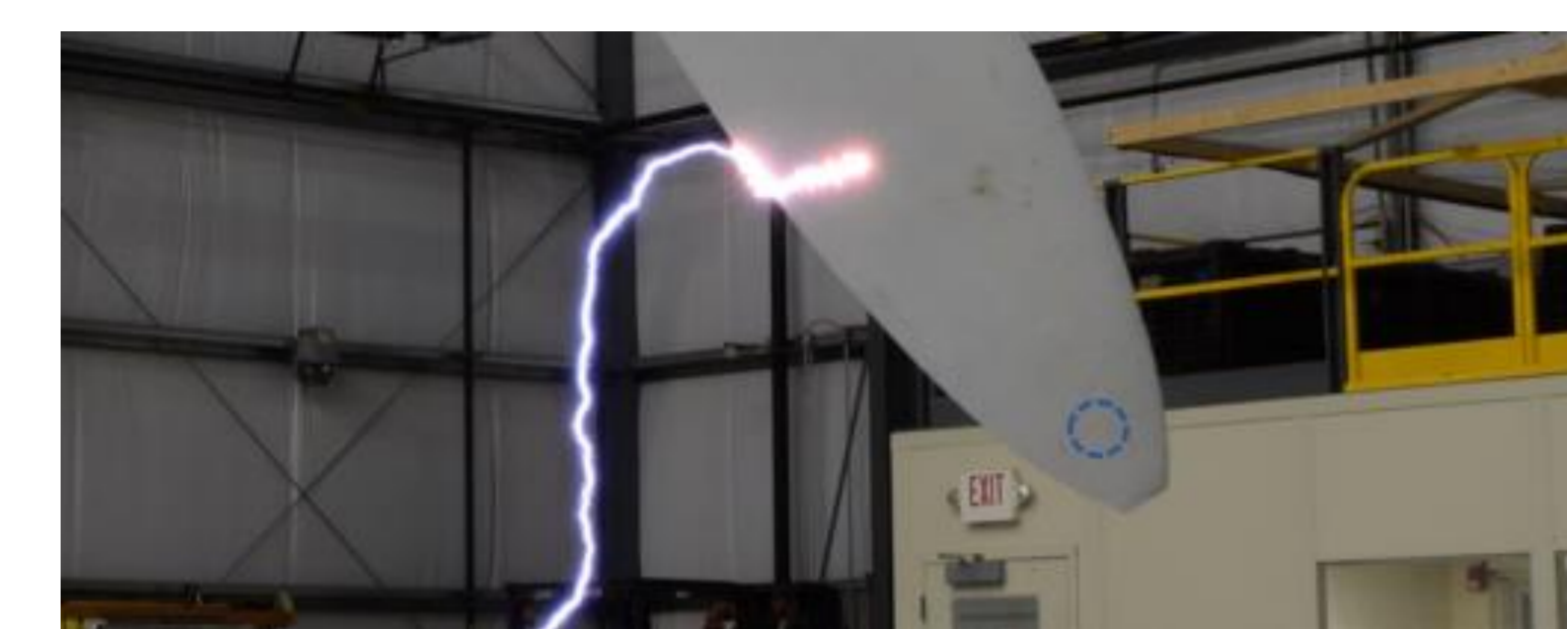
Laboratory Outcomes

Bad result: puncture to down conductor

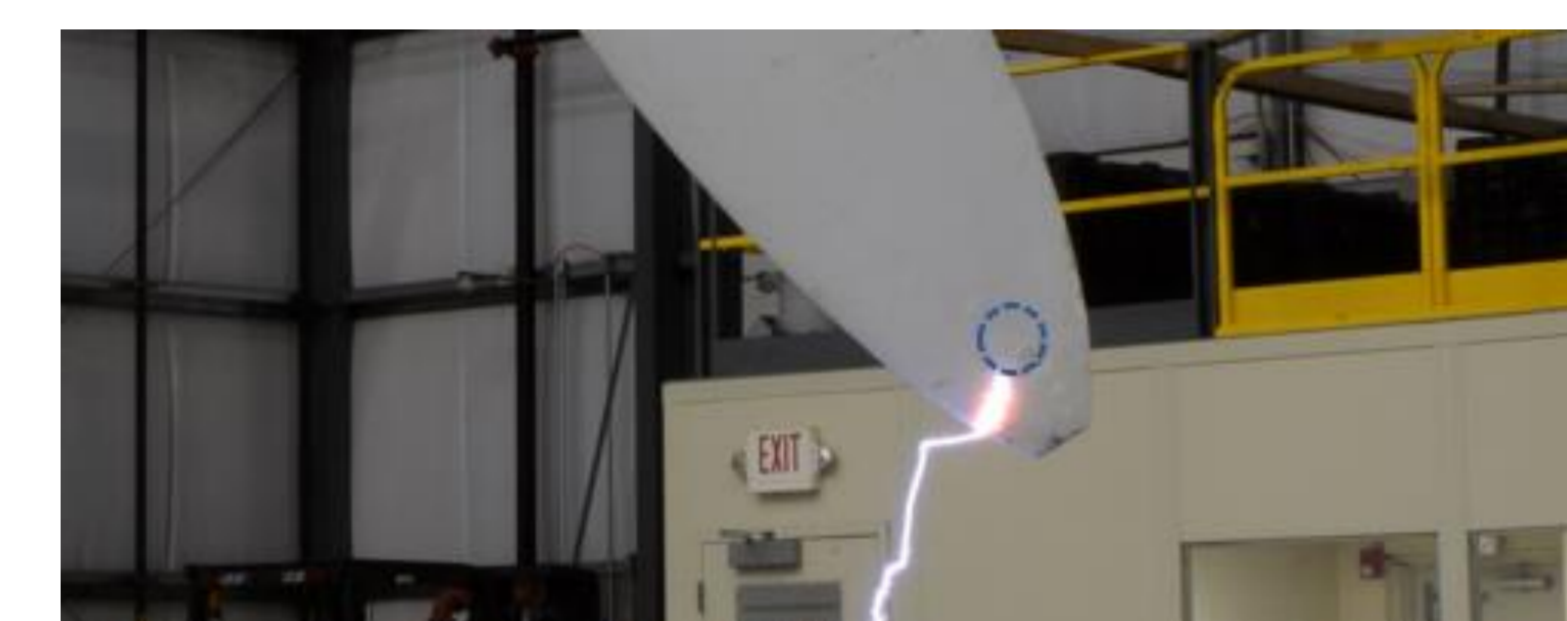
Good result: flashover to receptor

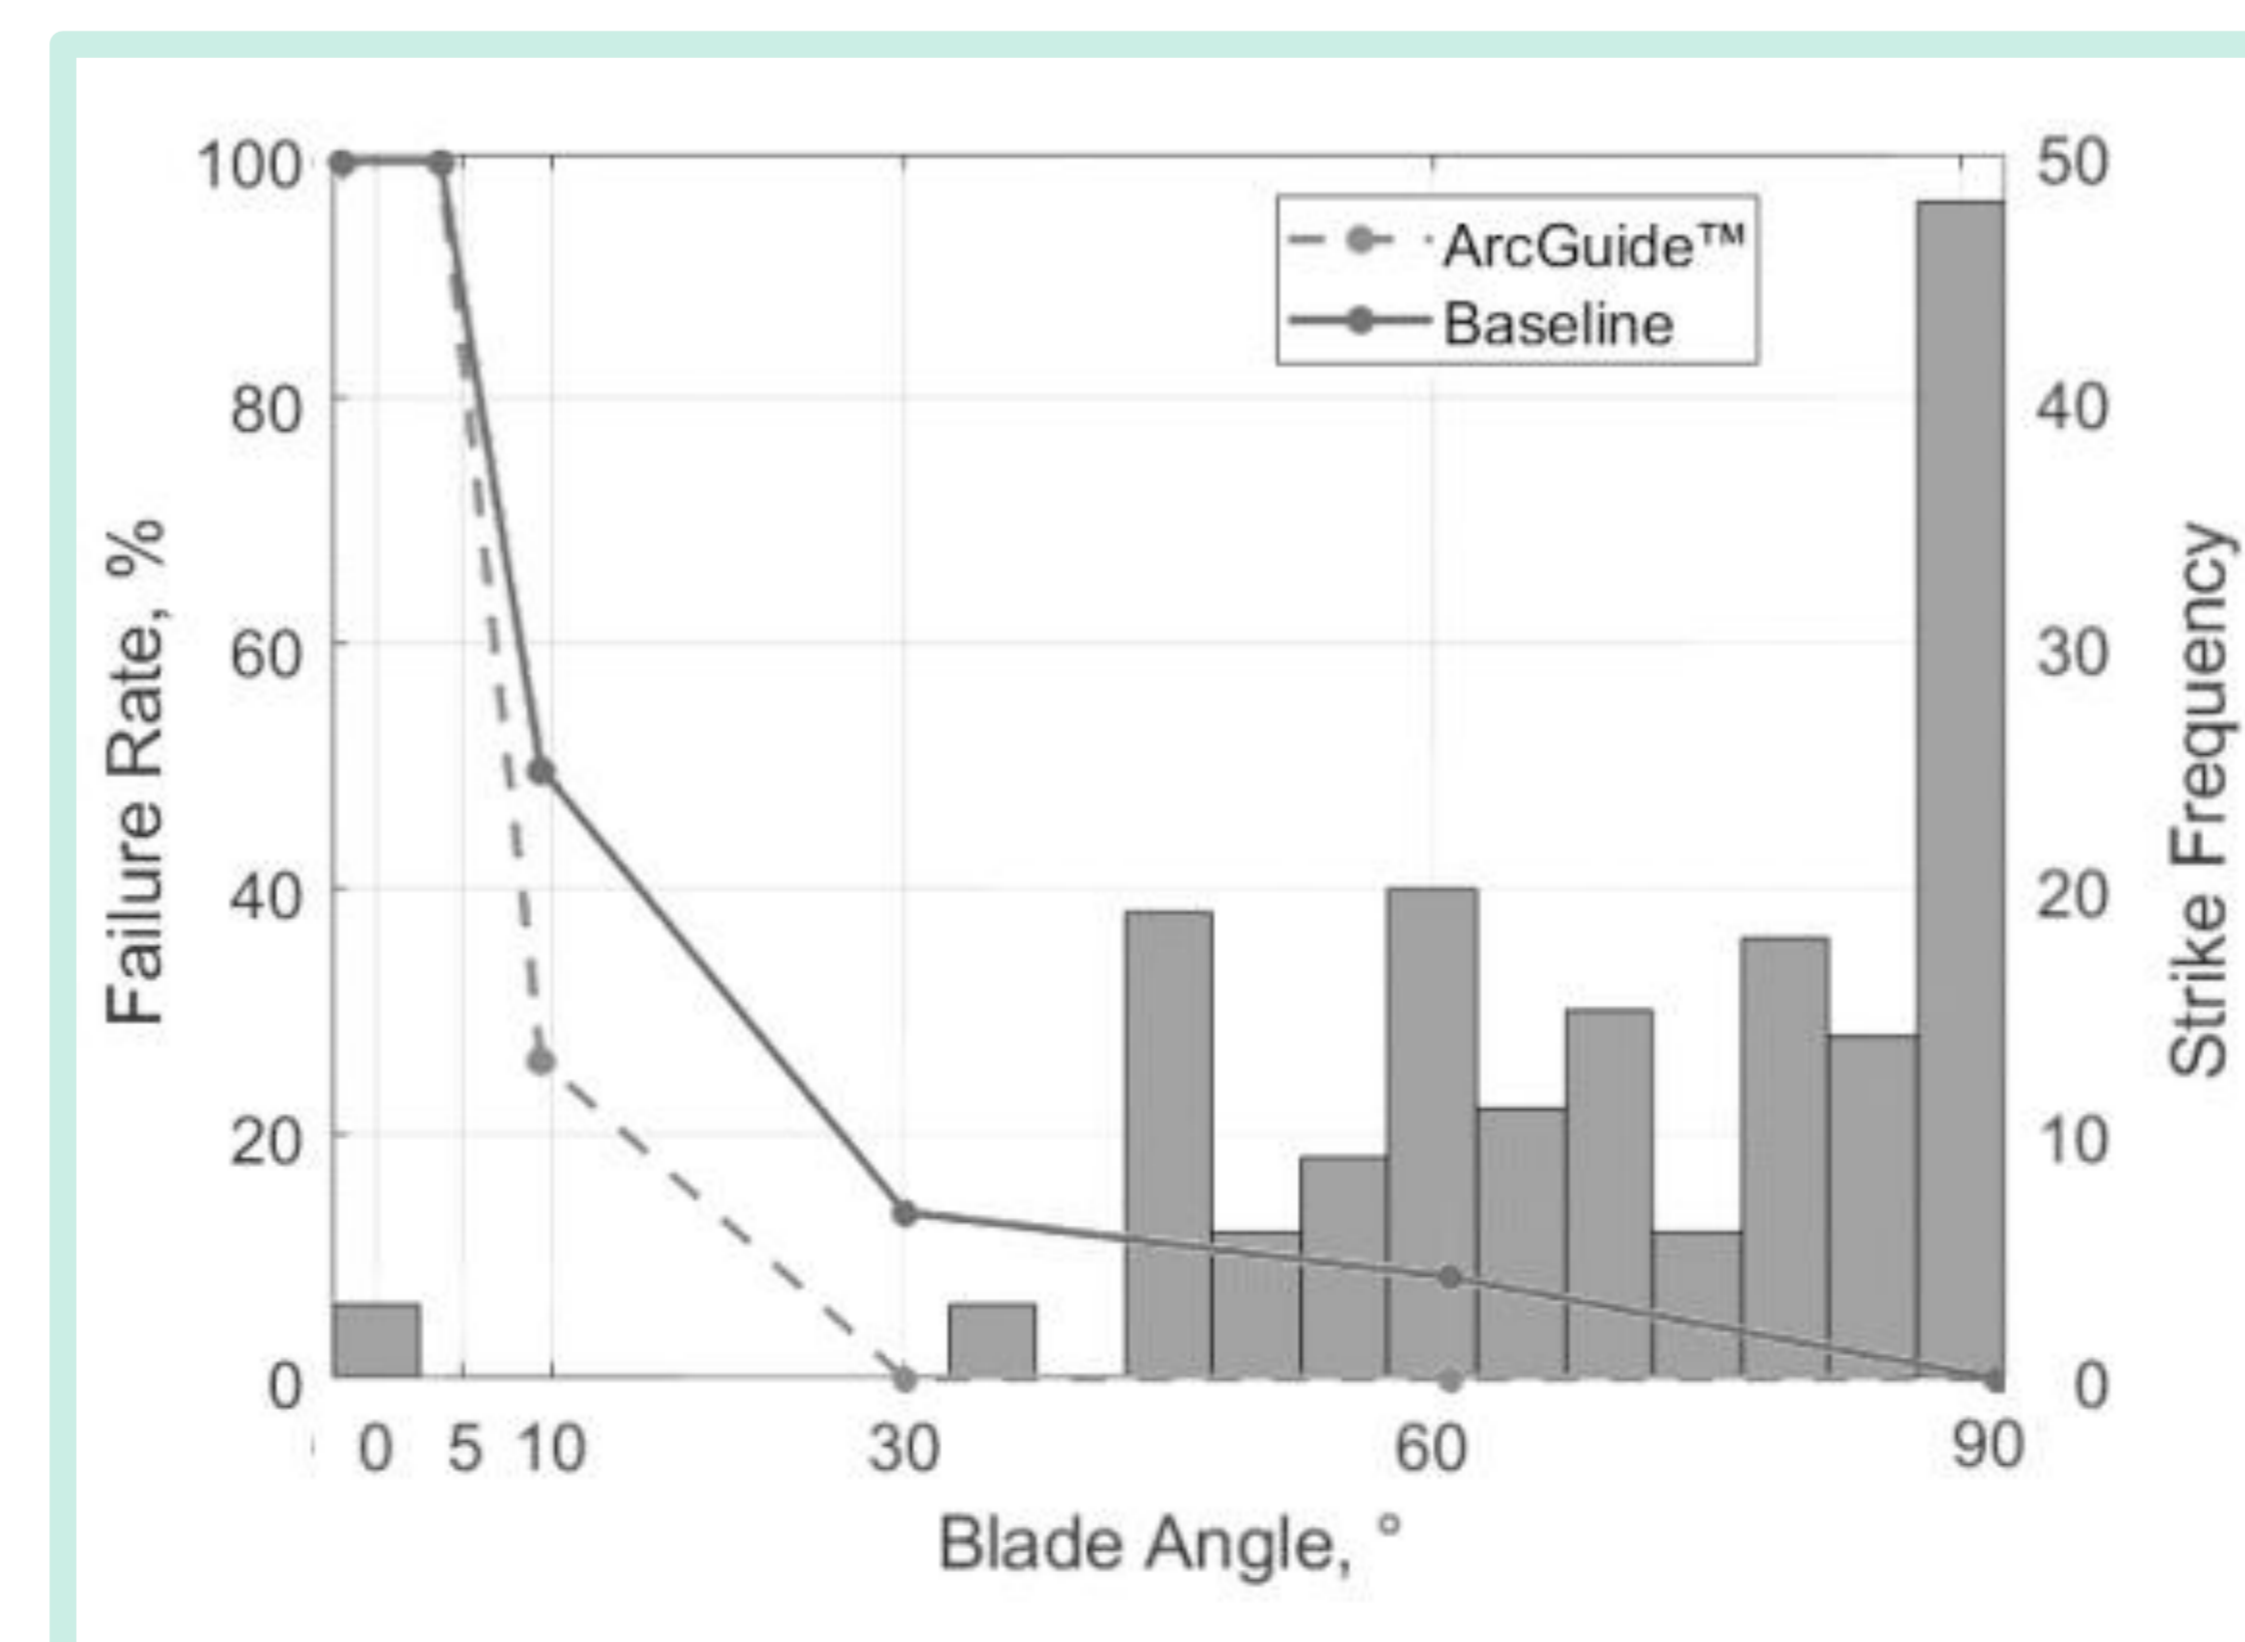
- A real-world attachment angle distribution was quantified from video footage of 172 winter lightning strikes on 12 turbines over 5 years^[3].
- 98% of lightning attachment in the field occurred at blade angles >30°.

- Applying the **baseline** failure rate to the field distribution:
 - 6.4%** of strikes are predicted to cause damage.
- Applying the **ArcGuide™** failure rate:
 - 1.7%** of strikes are predicted to cause damage.

- A **73% reduction**.

The number of punctures for each blade angle can be described by the failure rate:

- No punctures were observed at 90°
- Punctures always occurred < 10°
