Introduction

- Thoracentesis removes excess fluid from the lungs for diagnostic or therapeutic purposes.
- Complications following chest procedures include pneumothorax, bleeding complications, air embolism, and pulmonary re-expansion edema

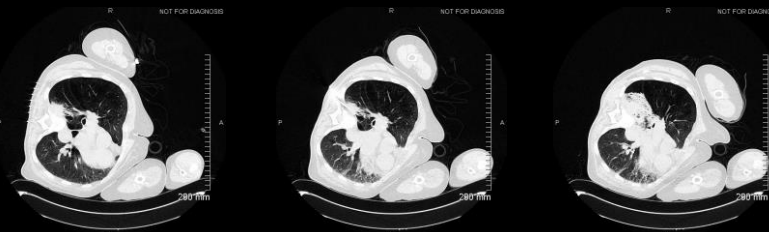
Bleeding Complication

61-year-old female with history of laryngeal cancer presented with a paraspinial/lung mass. The first transverse non-contrast CT was obtained prior to the procedure. The second image was taken during the procedure. The last image was taken following the procedure and demonstrates a right lung hematoma.

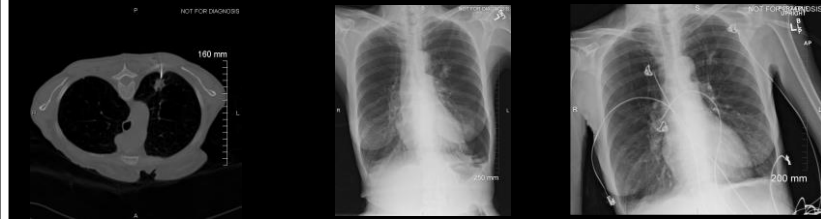
Pneumothorax

65-y.o. female w/ history of colon cancer s/p chemo/resection presented outpatient for CT-guided lung biopsy of spiculated left upper lobe nodule. The first image is a transverse non-contrast CT was taken prior to the procedure. The middle image was taken one hour after the procedure showing a large left-sided pneumothorax. Chest tube was placed during interval period. The final image was obtained one day after the procedure and shows resolution of the large pneumothorax.

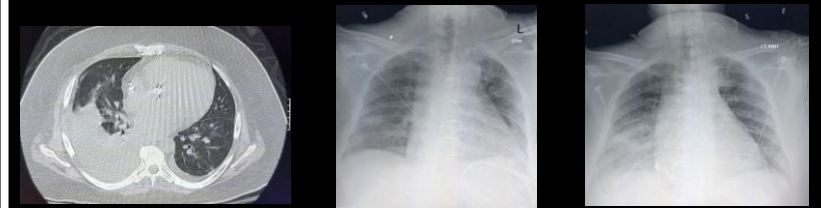
Pulmonary Re-expansion Edema

50-year-old male with aortic valve endocarditis, MRSA bacteremia, and history of aortic valve stenosis. First image shows moderate to large right pleural effusion on CT Chest. Second image shows immediate post-thoracentesis chest radiograph with improved aeration of the right lower chest. Third image shows new opacity overlying the right base which represents re-expansion pulmonary edema. The patient expired 1 hour following the last CXR.

- In our case series, only the re-expansion pulmonary edema case resulted in mortality.
- Patients with other complications responded to standard management and were promptly discharged.
